Marinus Link Project

Contaminated Land and Acid Sulfate Soils Assessment

Tetra Tech Coffey Pty Ltd

Reference: 754-MELEN215878ML_Sub_CSASS_R01

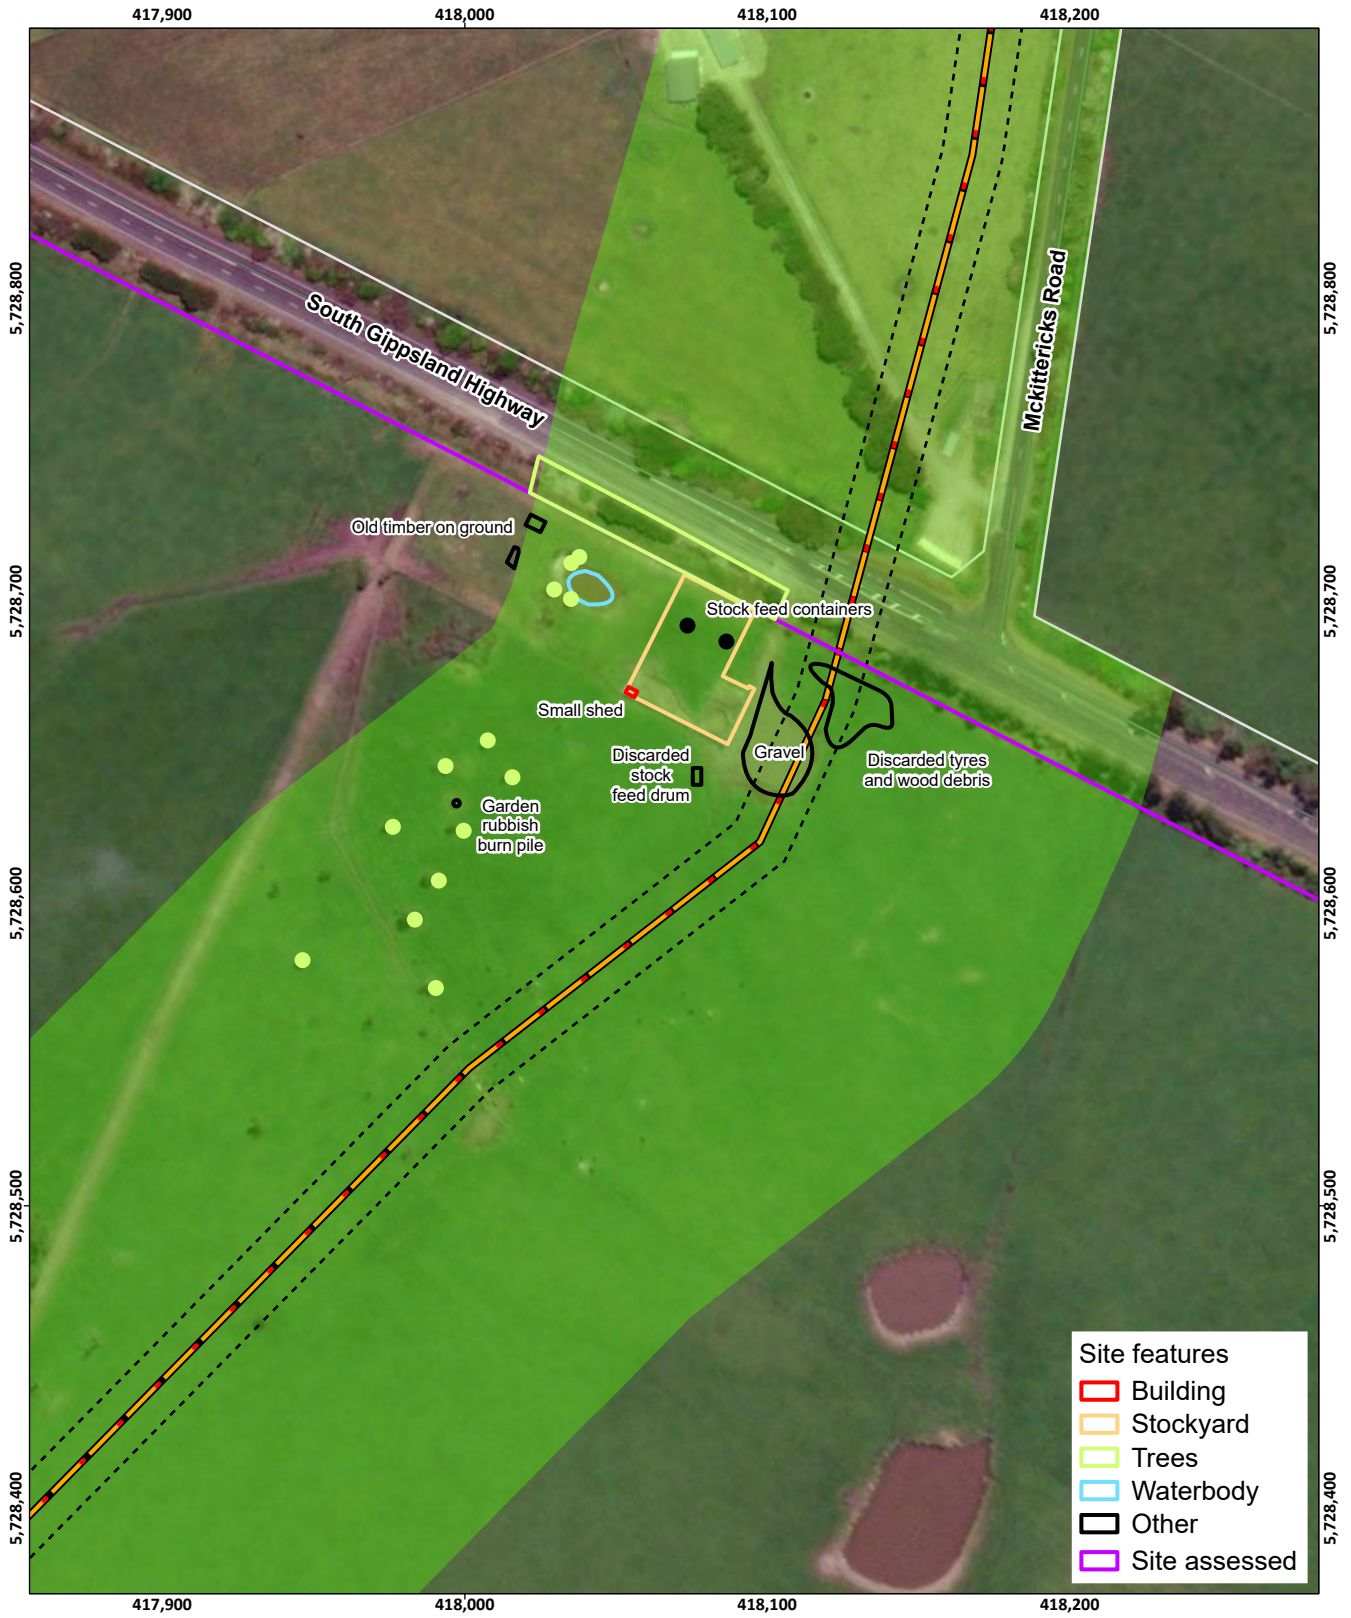
Figure 2.4: CSASS site inspection V0152 (19-20 May 2022)

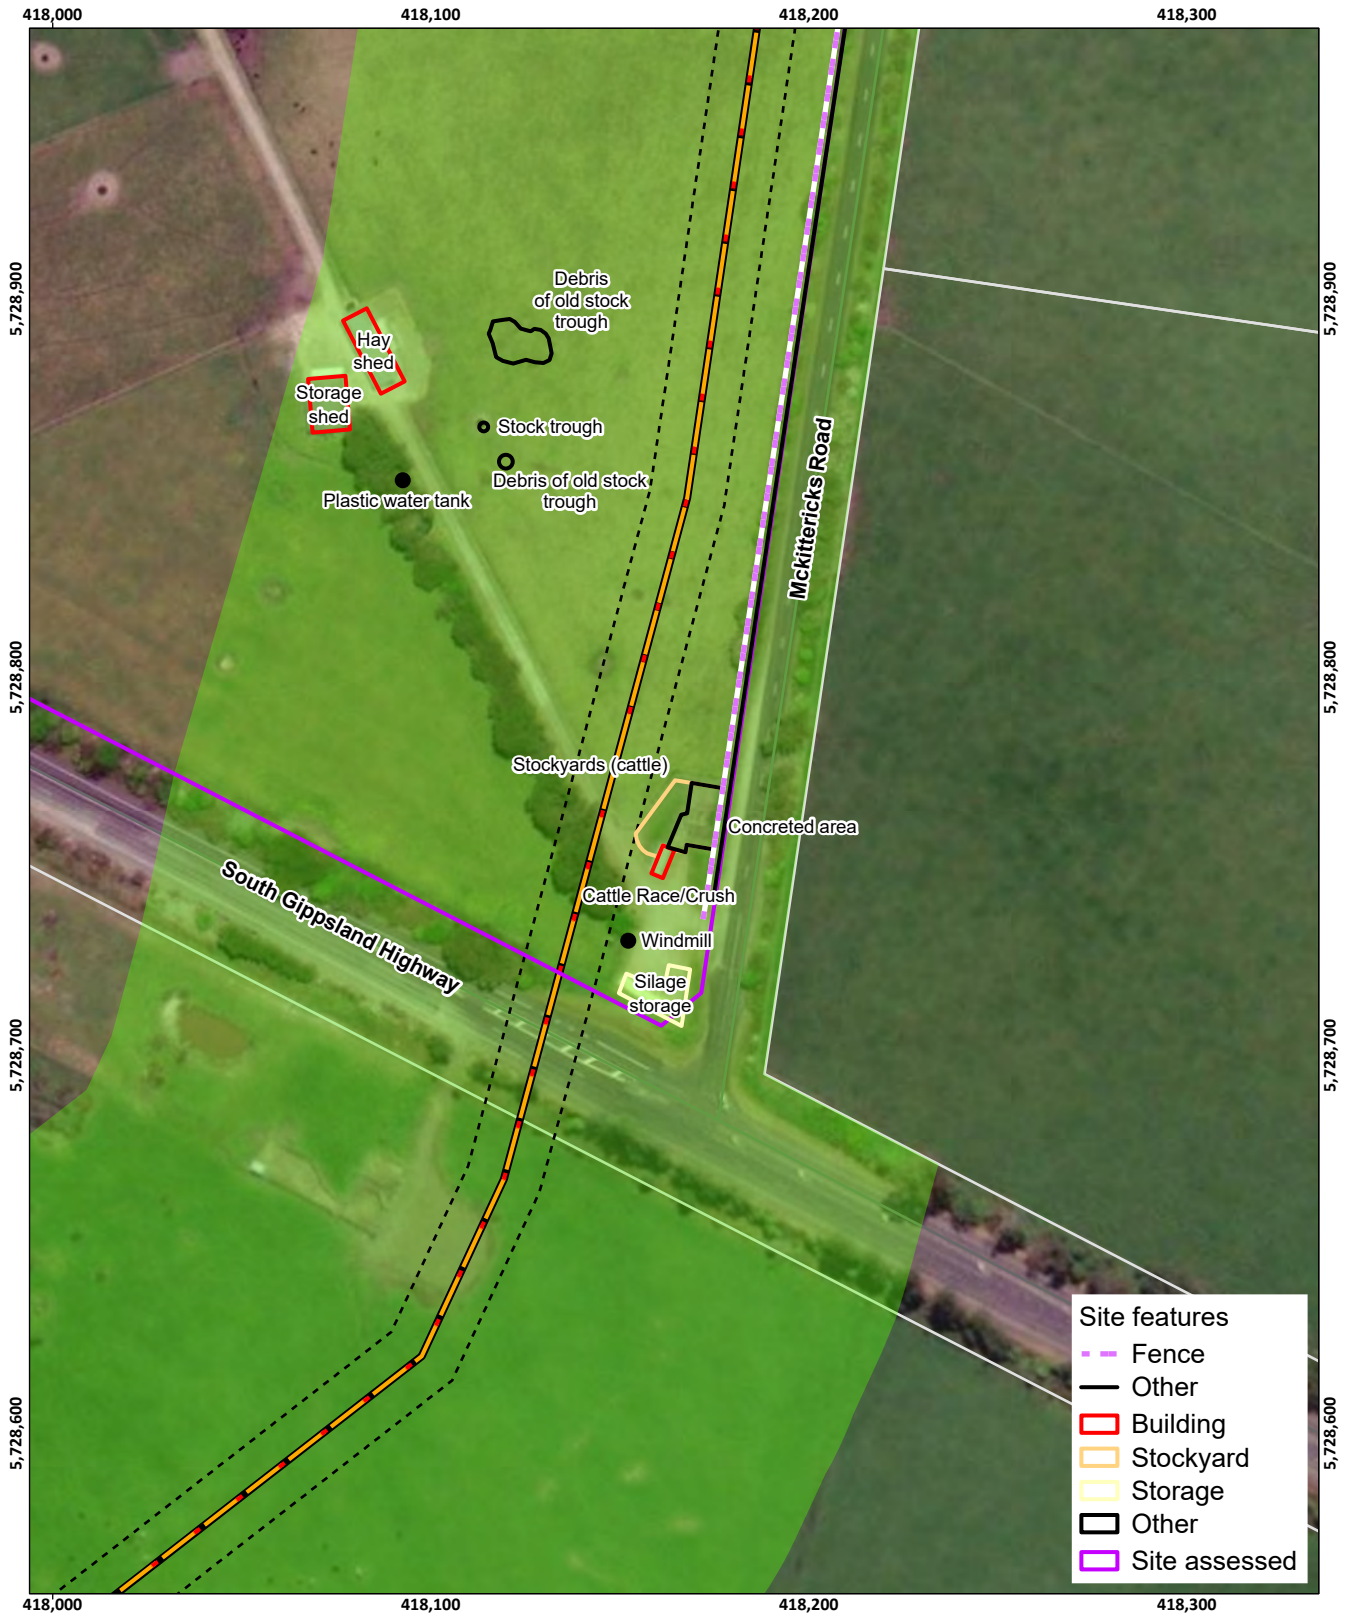
Figure 2.5: CSASS site inspection V0158 (19-20 May 2022)
