**Marine Benthic Habitat Characterisation**

# Marinus Link

## Marinus Link Marine Benthic Habitat Characterisation

### Technical Report

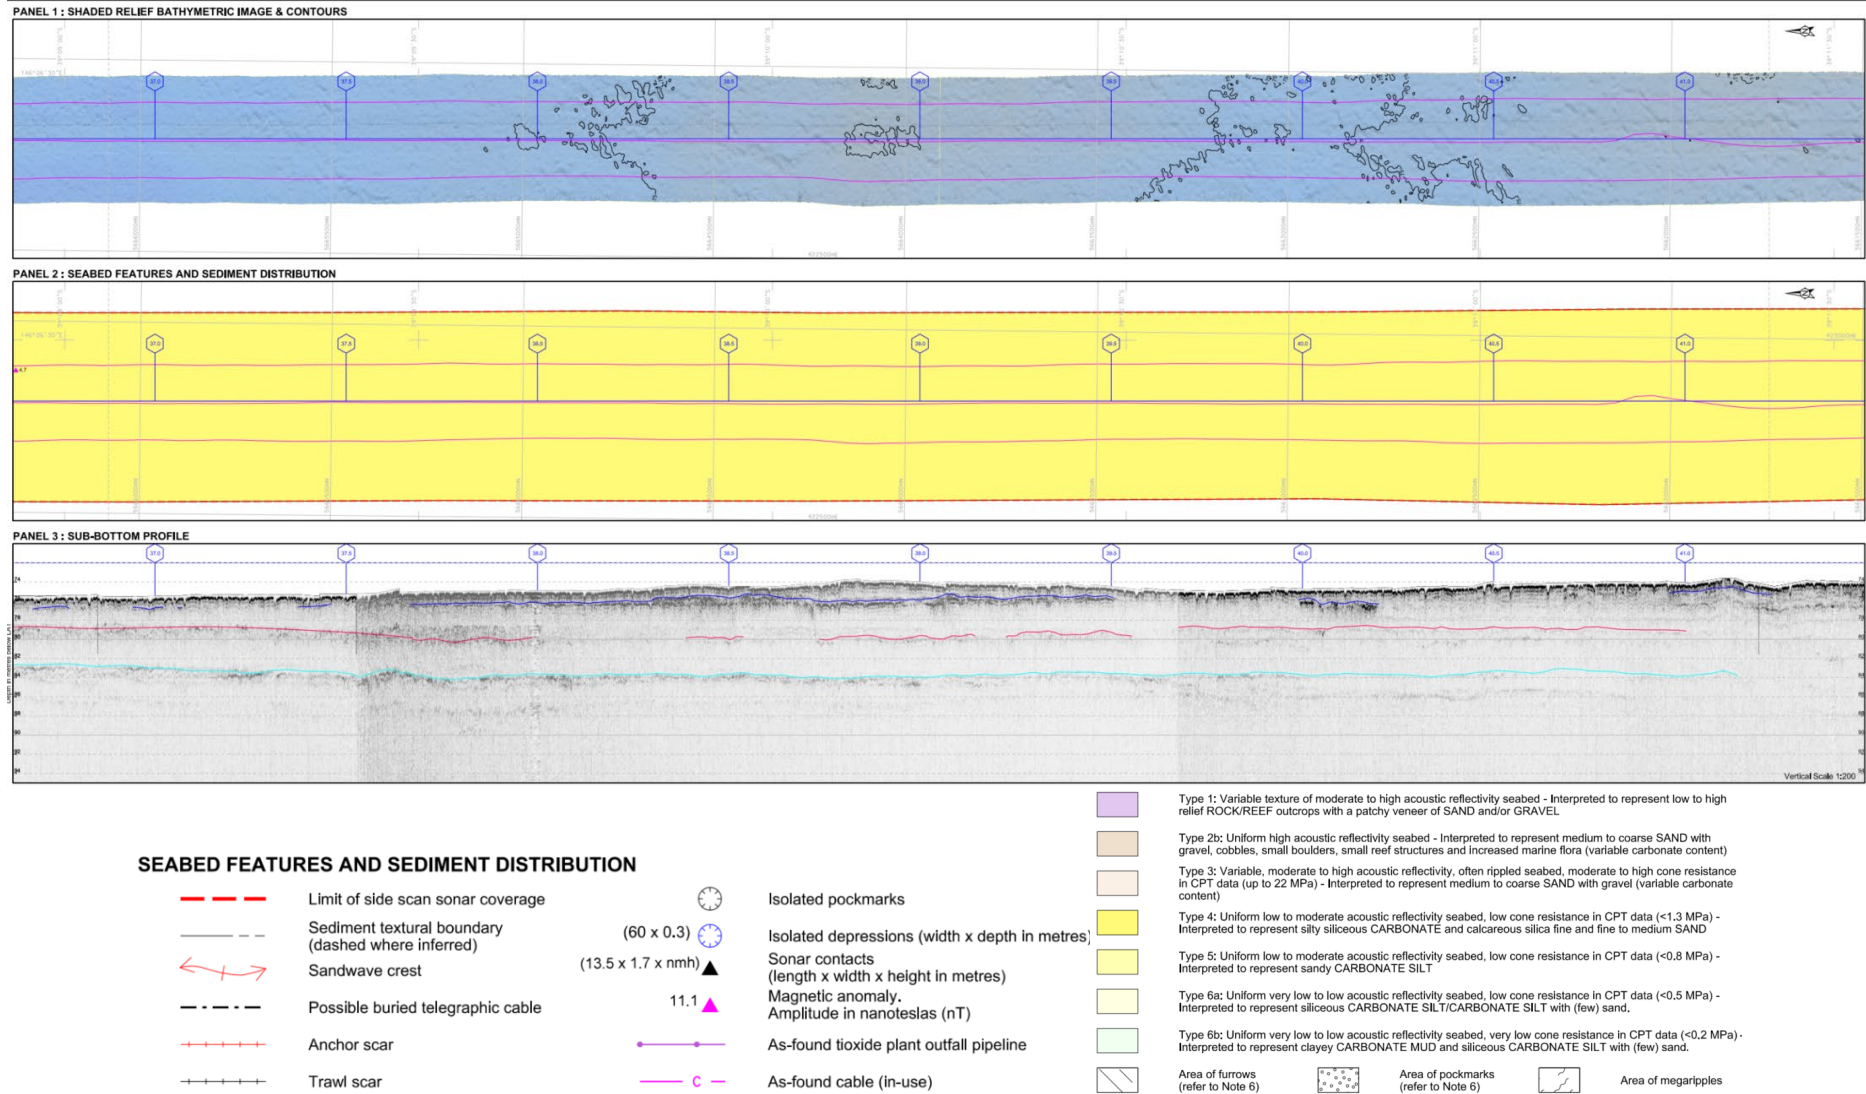
**Figure 2-3. Example of geophysical seabed characteristics from KP 36.5 to 41.5**  
(Source: Fugro 2020)

Differences in the composition of the unconsolidated sediments on the seabed were apparent as depths changed along the alignment and as the seabed became more sheltered from ocean swell closer to the Tasmanian coastline. The sites for the 2021 offshore seabed towed camera surveys along the offshore alignments were positioned to describe the general seabed and biological characteristics interpreted from the depth profiles and the geophysical survey features (Figure 2-3) provided in the geophysical report (Fugro 2020).

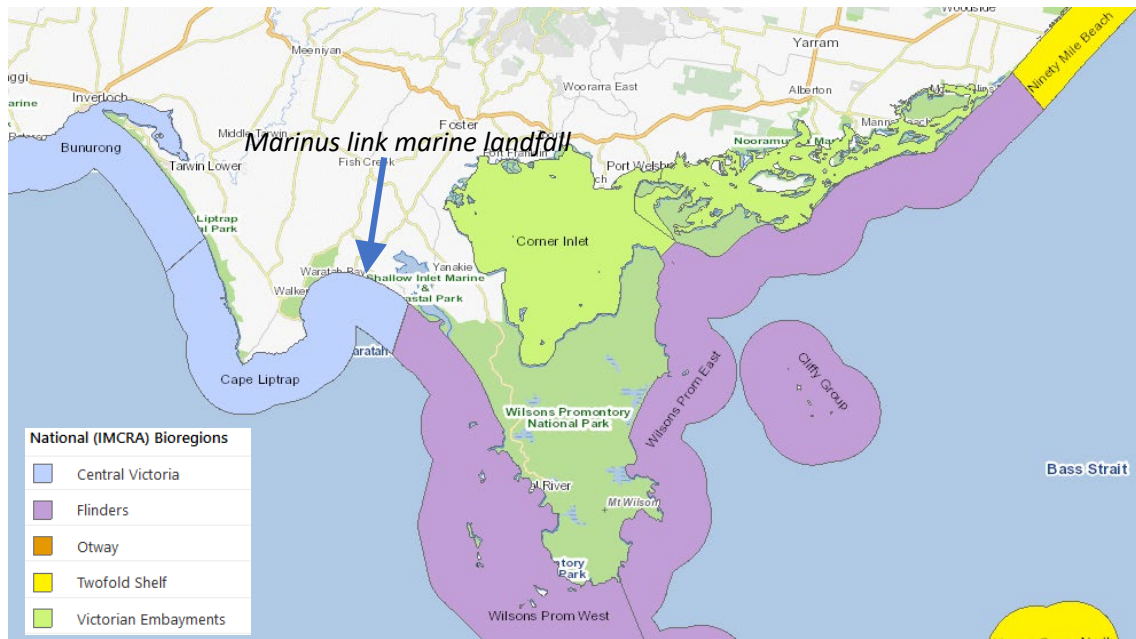
**Waratah Bay locality**

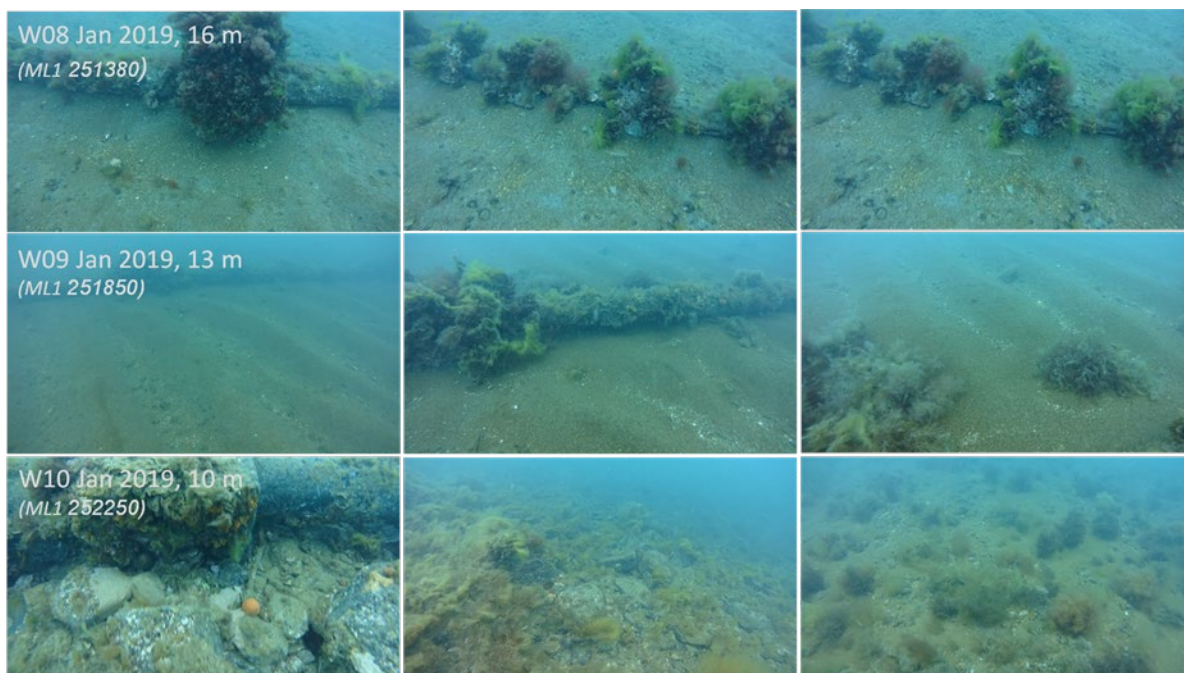
**Figure 5-17. Disused Tioxide pipeline, Jan 2019  
ML1 251,380, ML 251,850 and ML 252,250,**

The biological assemblage on the disused outfall pipeline shows the nature of marine biological growth that may colonise the external iron casing of a transmission cable laid across the seabed in this area of the north coast. Comparison of the biological growth on the pipeline in Figure 5-17 and Figure 5-18 compared to the lack of macroalgae in Figure 5-12 illustrates the seasonality of the biological growth in this region, which is also described for the Basslink cable at Five Mile Bluff located 80 km east of Heybridge (CEE 2021, Sherwood et al 2016).

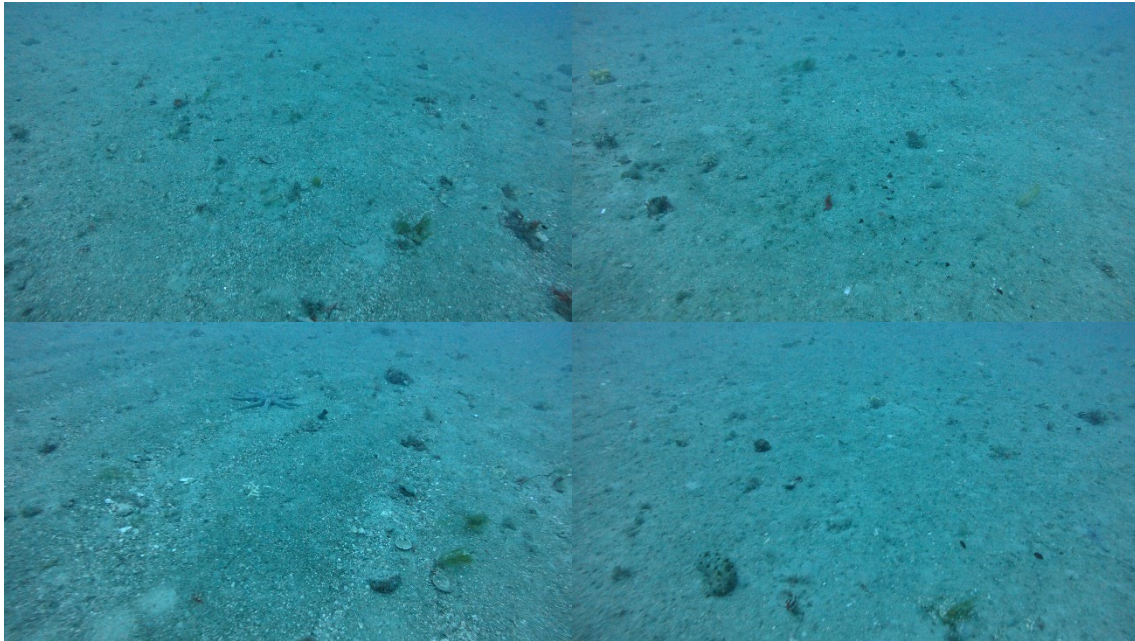
**Figure 6-5. Seabed biological community 38 m (2019 site C02)**

The seabed at 38 m depth (between ML1 247,300 or 2019 survey site C02) comprised finer sand and less shell than the shallower sites and the seabed was relatively flat with low undulations rather than the distinct sand waves evident at the shallower sites. The small, stalked bryozoan *Lanceopora smeatoni* appears as small black shapes was more common than the 35 m site. The green alga *Caulerpa longifolia* was present in low abundance. Doughboy scallops were sparsely scattered over the seabed, while commercial scallops were present but scarce.

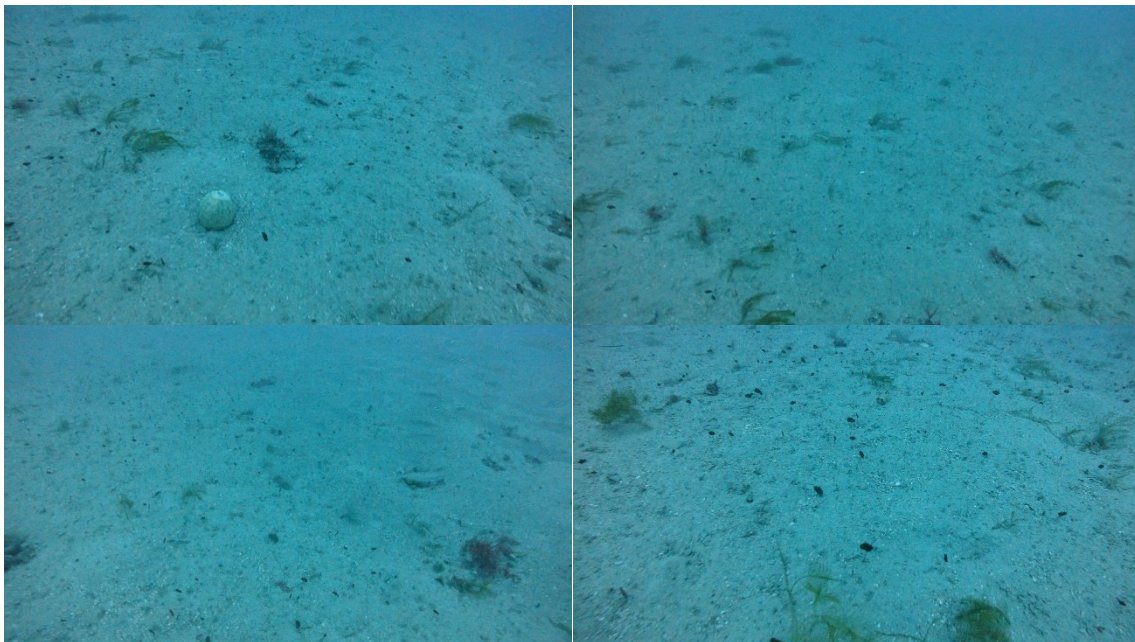
**Figure 6-6. Seabed biological community 41 m (Site C01, 2019)**

The seabed at 41 m water depth corresponding to ML 246,200 (2019 survey site Bly 001) was characterised by a flat sandy seabed with no obvious burrow mounds (Figure 6-6). Visible epibiota were sparse. The small, stalked bryozoan *Lanceopora smeatoni* was present in higher abundance than the shallower sites Figure 6-6. The colour of these invertebrates is actually red, but they appear black without artificial light in the image because red light is removed by the water column. Other biota included the green alga *Caulerpa longifolia* and sparsely distributed commercial (*Pecten fumatus*) and doughboy (*Chlamys asperrima*) scallops. A school of small pelagic fish (possibly juvenile mackerel or Australian snapper) followed the camera at this site.

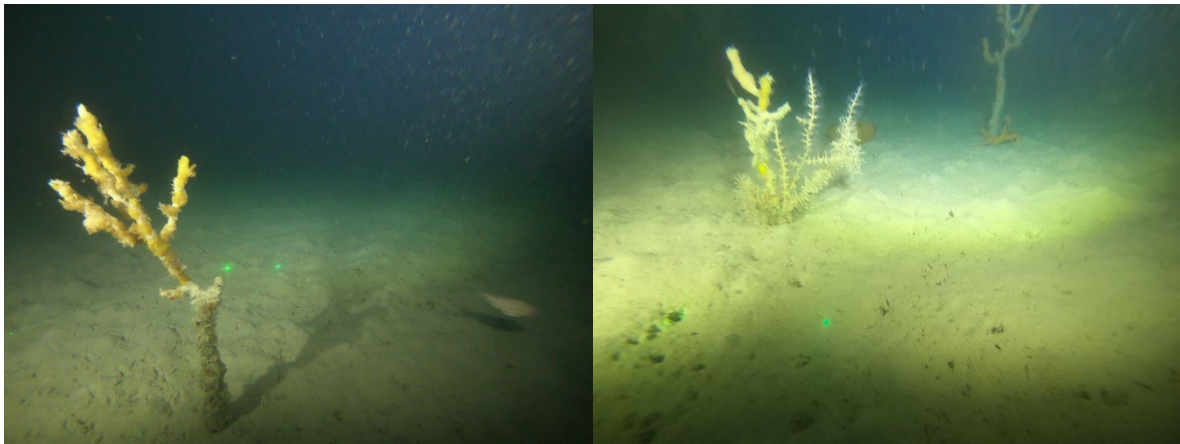
Figure 6-9. ML 230,000 Encrusted eunicid worm tubes and soft coral (right)

The seabed ML 230,000 to ML 180,000 was characterised by silt with abundant mounds of burrowing biota (Figure 6-8). The seabed in images from these sites was otherwise bare except for the re-appearance of sparsely distributed overgrown worm tubes at ML 230,000, together with a slender branched soft coral (octocoralline), which can be seen with extended tentacles in Figure 6-9.

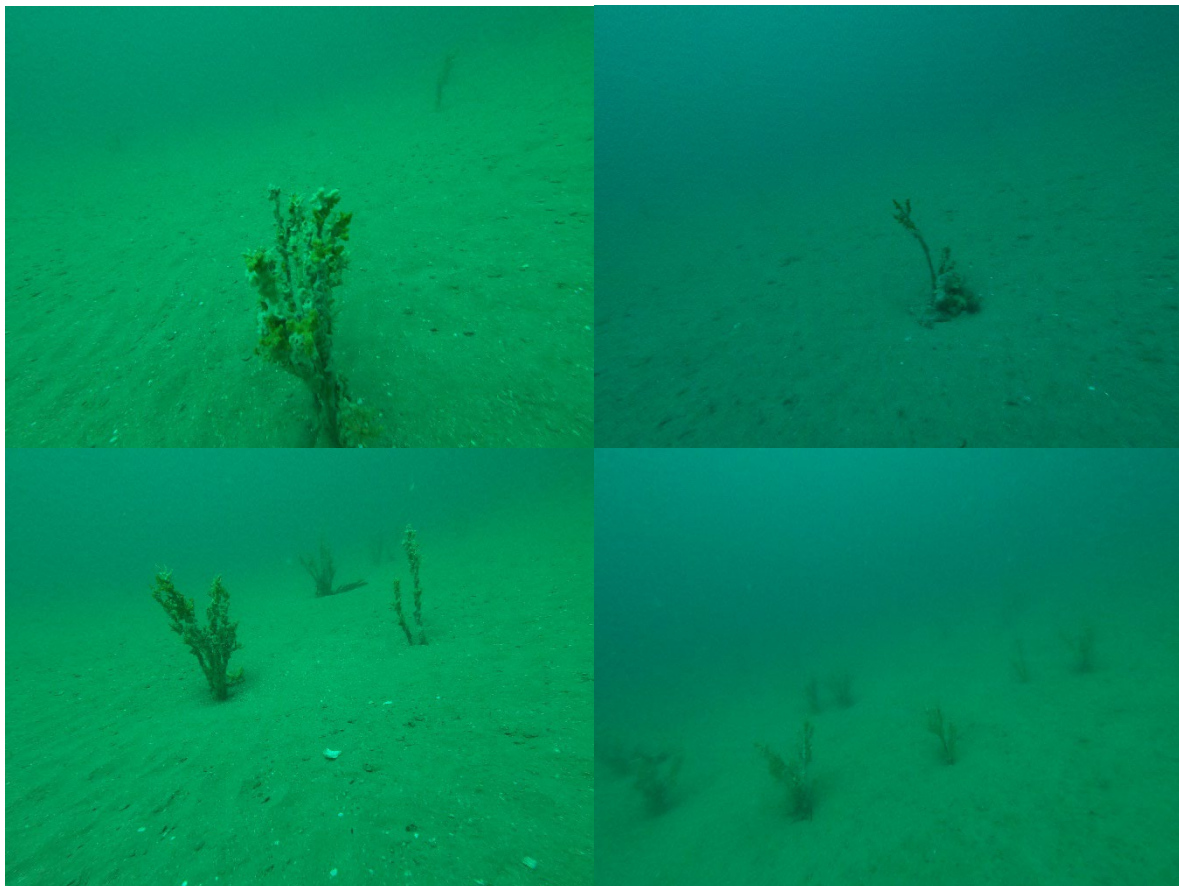
Figure 6-12. Overgrown Eunicid worm tubes: ML 20,000; ML10,000; and ML 8,000

The notable biological feature of the seabed was the presence of sparsely distributed erect invertebrate colonies (Figure 6-12). This feature is likely to be the erect branched tube of a colony of Eunicid worms (Dr Robin Wilson, Museums of Victoria, *pers comm*). The tube may outlast the worm (or worms) themselves and provide a solid surface for attachment of other invertebrates such as sponges. These appeared to be most abundant at ML 8,000 (depth 42 m) with numbers appearing to decrease as depth increased to 74 m at ML 40,000. They appeared to be absent from the seabed from sites at ML 210,000 (depth 69 m) to ML 70,000 (depth 75 m) before reappearing at ML 230,000 (depth 69 m), 22 km offshore from Burnie in Tasmania. This feature appears similar to the “intermediate bushy sponge” reported in the South-East Shelf Survey (Bax and Williams 2001) and worm tube colonies identified in North Arm of Western Port (CEE 2021).

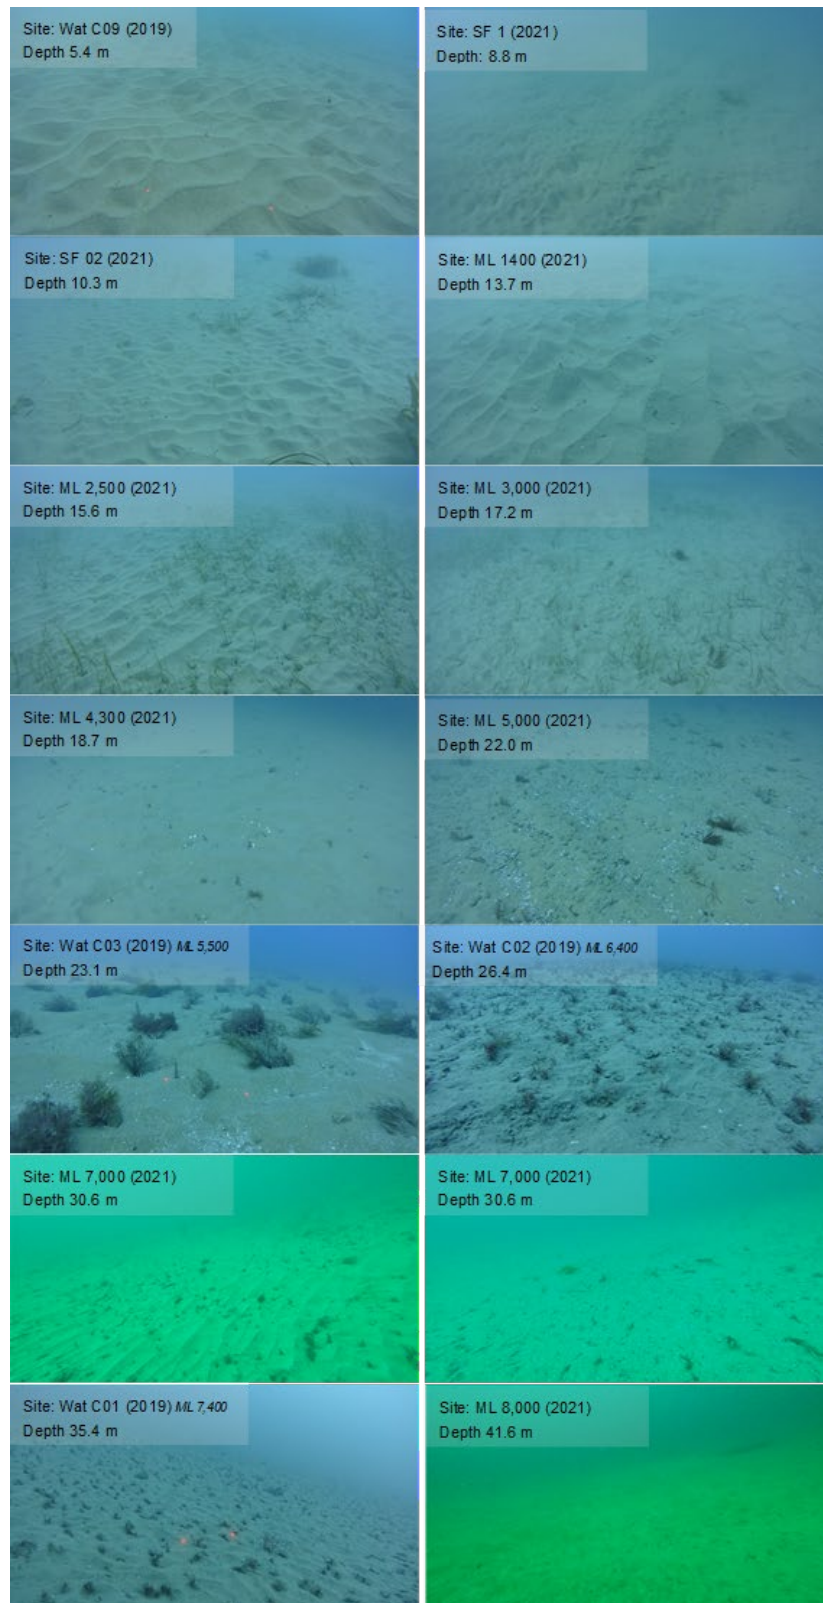
**Figure 7-10. Examples of sandy seabed features from shore to 8,000 (2021)**  
(Differences in blue and green colour and resolution result from different cameras  
blue = Sony camera; Green = GoPro camera)

The seabed at ML 8,000 was fine sand with irregular flat plates that appeared to be consolidated sand scattered irregularly across the seabed. The absence of biological growth on these objects indicated that they may move during storms.

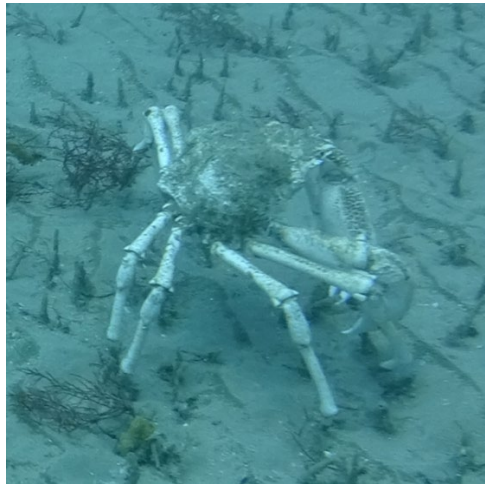
**Figure 7-15. Spider crab *Leptomithrax gaimardii***  
Site ML 6,000, 26 m depth 2021

Examination of the photographs from the soft seabed sites showed a seabed mostly bare of sedentary animals, such as seastars, scallops or snails (gastropods). The absence of these epifauna may be due to the wave action in Waratah Bay and the regular disturbance of the seabed sediments and any unattached biota living on the seabed. Three solitary spider crabs were observed: one on tow ML 6,000 at 26 m depth (Figure 7-15); another on tow ML 6,300 at 26 m depth; and the other on tow ML 7,000 at 31 m depth.

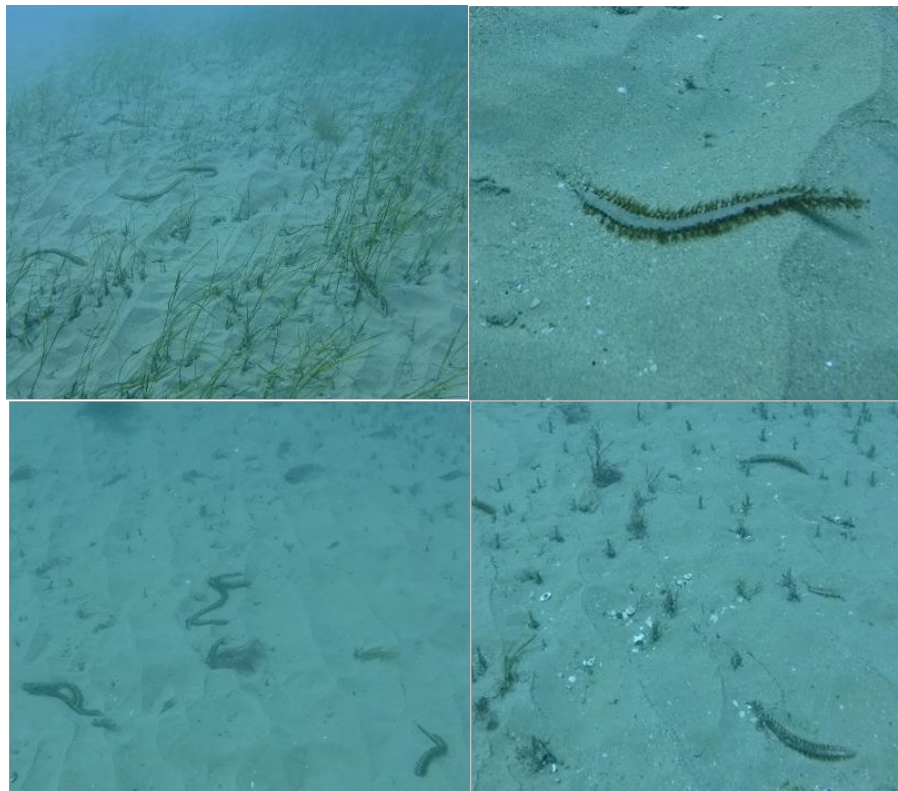
**Figure 7-16. *Pseudogorgia godeffroyi* in Waratah Bay, November 2021**

The notable exception to the relative absence of epifauna on the soft seabed was the 'sea pen' (*Pseudogorgia godeffroyi*). This soft octocoral, related to gorgonians and sea whips, extends its foot into the sand to maintain position and feeds using rows of short tentacles extending along each side of a central ribbon-like axis.

*Pseudogorgia godeffroyi* were sparsely distributed as patches or individuals over the seabed in both the 2019 and 2021 surveys along the sandy seabed of the alignment from 14 m depth at ML 1,700 to 31 m depth at ML 7,000. They were observed also in patches of sparse to moderate *Heterozostera tasmanica* seagrass. *P. godeffroyi* was absent from Waratah Bay sites deeper than 31 m. Figure 7-16 shows *P. godeffroyi* in Waratah Bay in 2019.

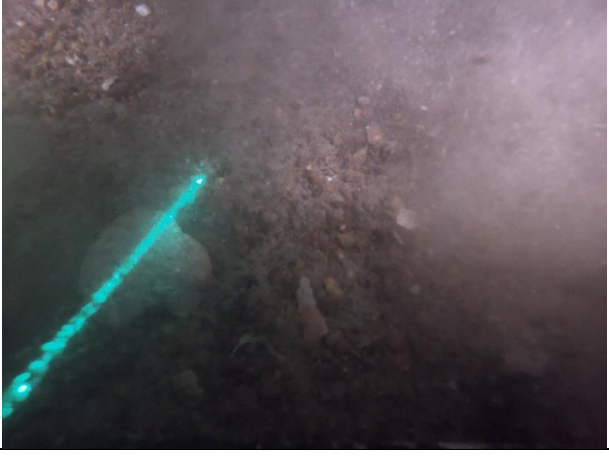
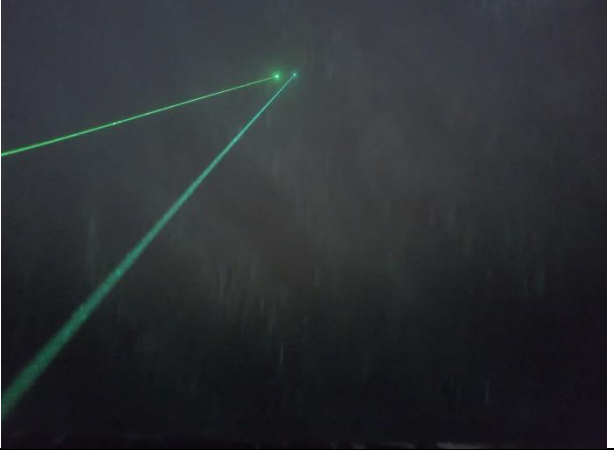
ML2 250,000	31m

The seabed at 31 m water depth at ML 249,000 was medium to coarse grained sand waves. Shell and other organic material, including living and empty doughboy scallops, had accumulated in the sand wave troughs. Eleven-arm seastars (*Coscinasterias muricata*) were observed feeding on the scallops, which was likely responsible for the many still-joined dead shells in the troughs. Other biota observed on the medium to coarse sands of this habitat included solitary anemones and sand flathead fish.
