Appendix O

Supporting Technical Memos

Heybridge Foundations and Construction – Technical Memo

HVDC CABLE CROSSING OF TIOXIDE OUTFALL

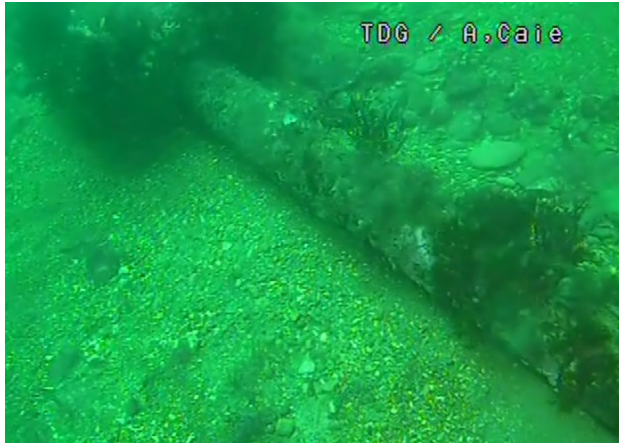
Figure 4 Pipeline inspection showing intact pipeline, algal growth and works to cut into the pipeline.

The pipeline was observed to be in good condition overall with no obvious or observable cracks (Figure 4). Note however that small leaks or openings would be difficult to detect due to algal growth and a lack of discharge.

The pipeline was secured to the seabed by steel banding in areas of rocky reef and by concrete collars in regions of unconsolidated material (i.e., sand, cobble or shells).

Overall, the survey determined that the pipeline is structurally intact.
