Marinus Link

Contaminated Land and Acid Sulfate Soils Impact Assessment – Heybridge Converter Station, Tasmania

Tetra Tech Coffey Pty Ltd

20 November 2024

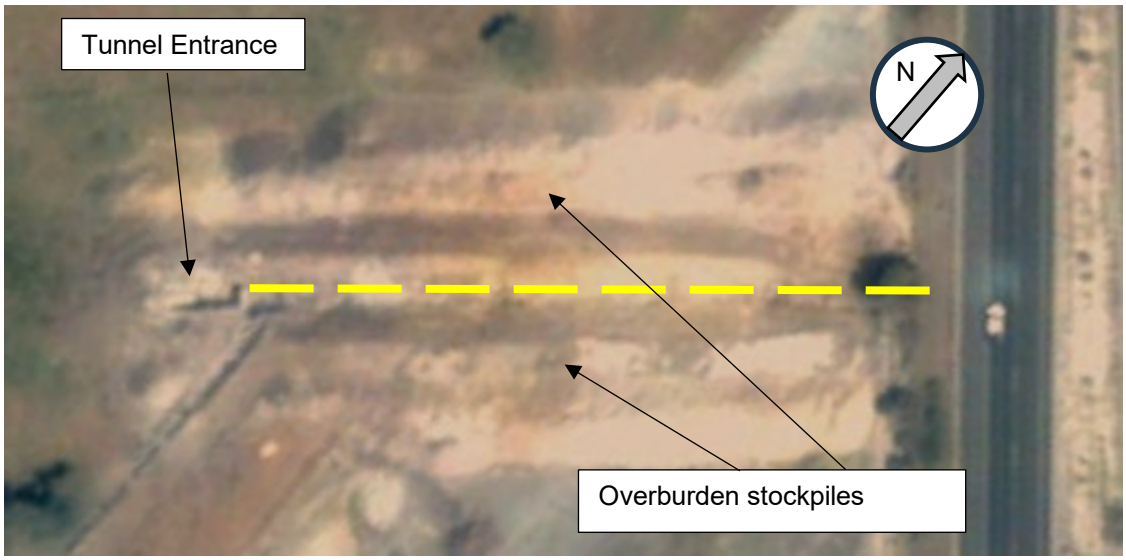
No reports or records regarding the completion of the tunnel works were available for review (from either the EPA or other sources) which documented the remediation and/or validation of the tunnel or pipeline. However, an aerial photograph from January 2008 appears to show that the tunnel had been uncovered, with two stockpiles of overburden either side of the tunnel alignment (Figure 11).

Figure 11: Aerial photograph from 2008 showing tunnel exposure (tunnel in yellow)

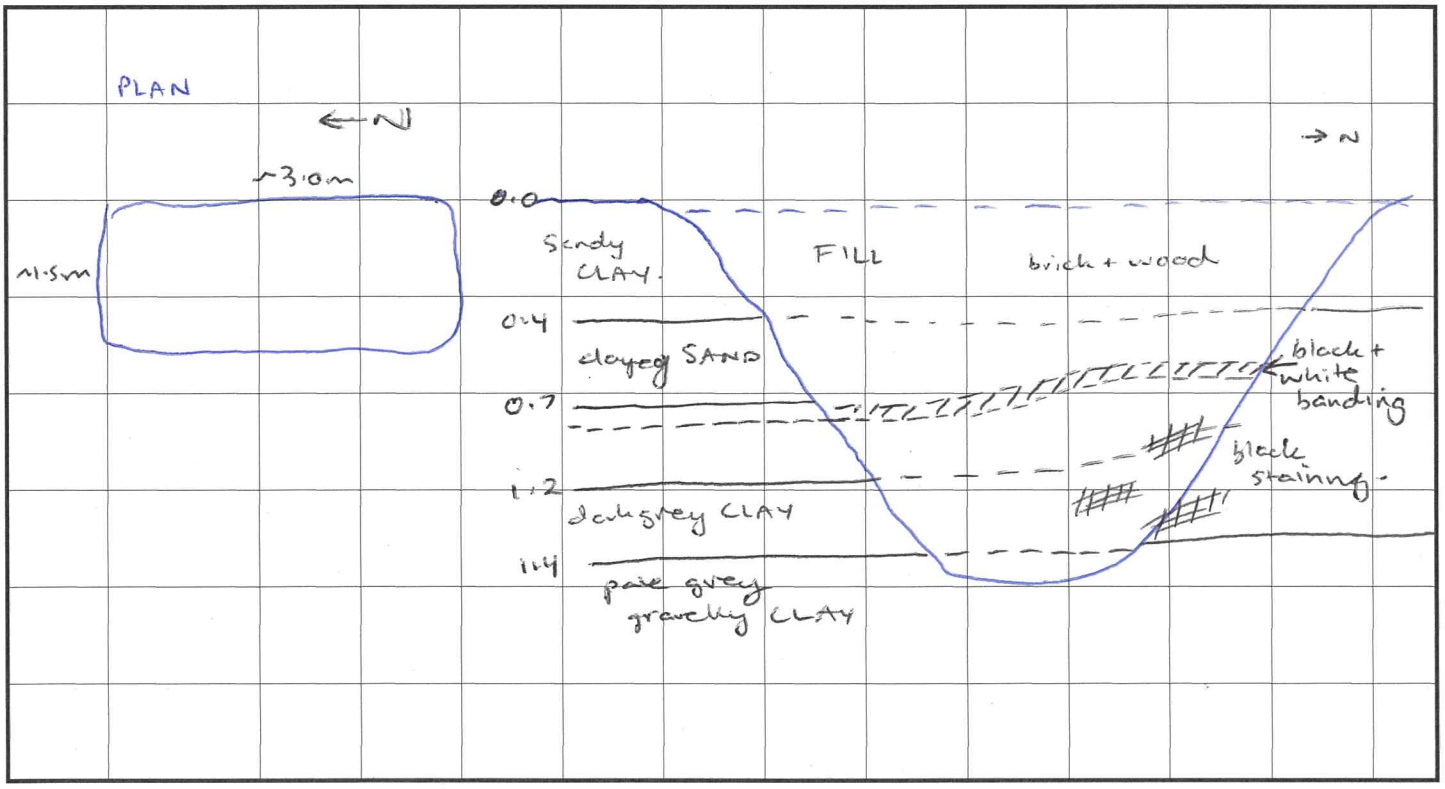
Sample ID	Soil Description (soil type, moisture, colour etc)	Depth (m)	Staining/ Odour (descriptive)	PID (ppm)
FILL HEY1_0.0-0.2	sandy CLAY, with gravels, brown-grey, fg. brick and wood debris	0.0-0.2		
HEY1-0.6-0.7	clayey SAND, cg with gravels, dark grey with black + white mottling (staining?)	0.6-0.7	black + white stain?	
DIST. NAT? HEY1-0.9-1.0	clayey GRAVELS with sand, dark grey with cemented chunks	0.9-1.0	black mottling / staining.	
NAT HEY1-1.4-1.5	gravelly CLAY, MH-HP, pale grey with quartz pebbles + coarse sand	1.4-1.5	sulfur odour

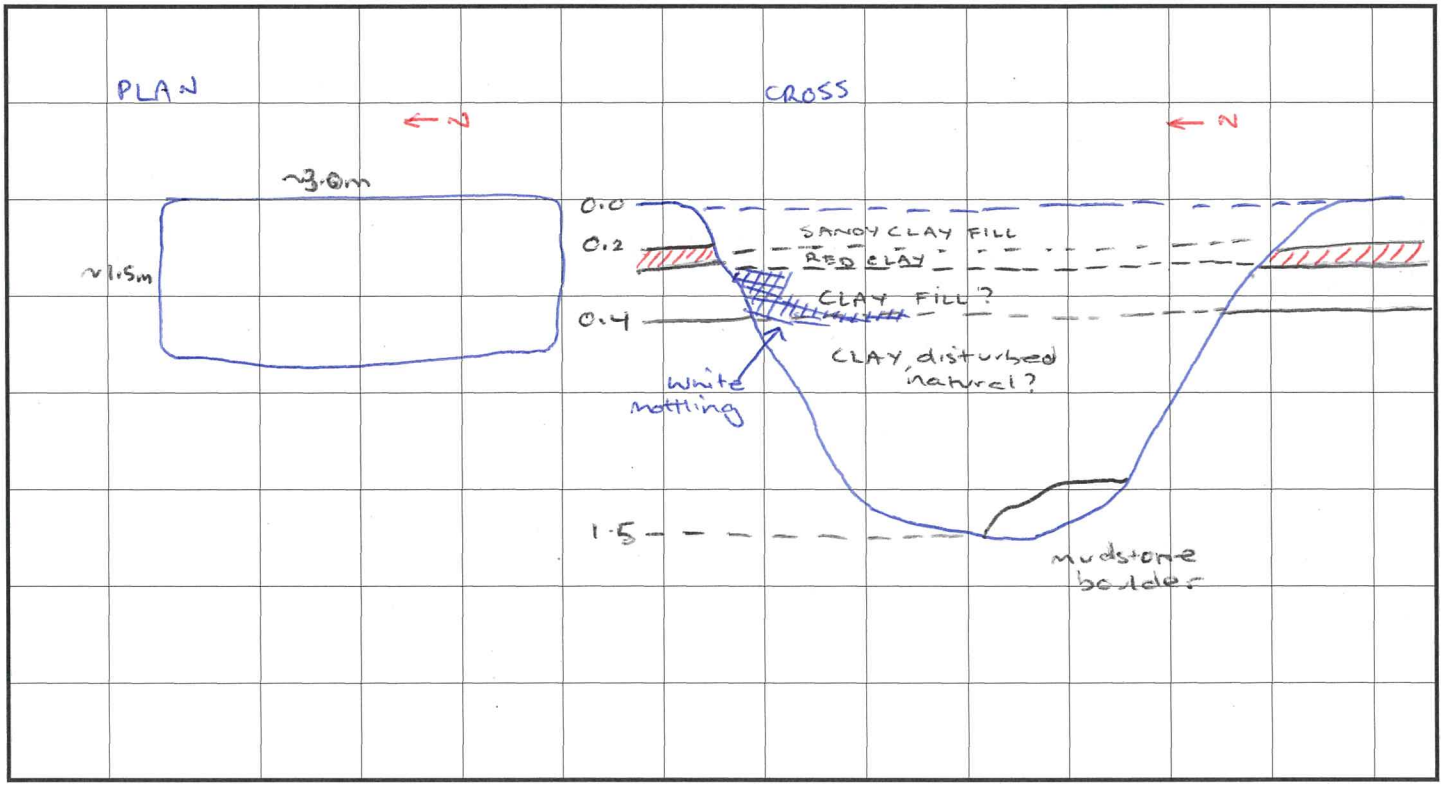
Sample ID	Soil Description (soil type, moisture, colour etc)	Depth (m)	Staining/ Odour (descriptive)	PID (ppm)
FILL	HEY2_0002	Sandy CLAY, with gravels, red-brown	0.0-0.2	N/A	N/A
	HEY2_0.6-0.7	CLAY, dark-brown with rootlets and charcoal fragments	0.6-0.7	"	"
	—	misplaced sample 0.9-1.0		"	"
DIST NAT?	HEY2_1.4-1.5	CLAY, dark brown with mudstone boulder disturbed natural? moist.	1.4-1.5	"	"

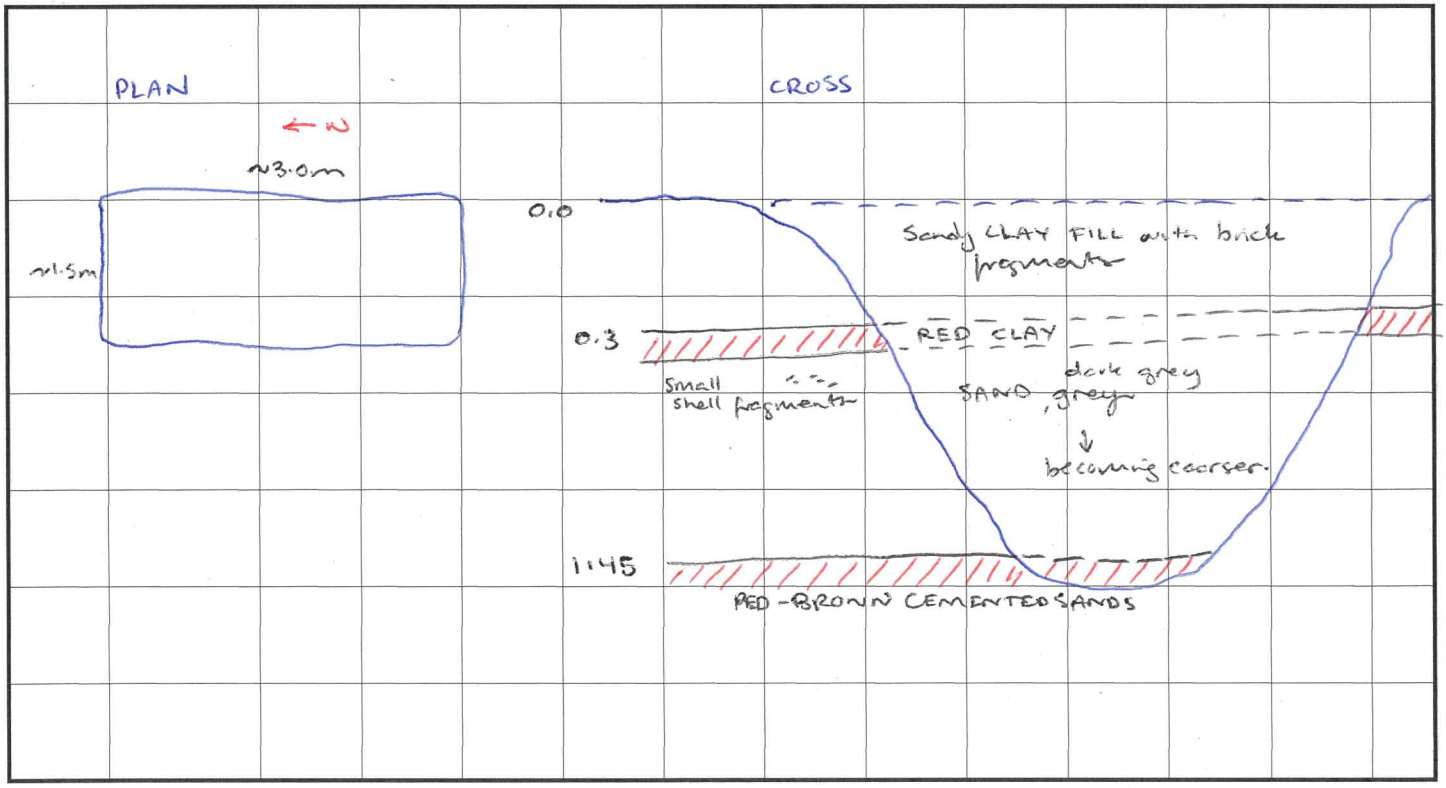
Sample ID	Soil Description (soil type, moisture, colour etc)	Depth (m)	Staining/ Odour (descriptive)	PID (ppm)
FILL. HEY3-0.0-0.2	Sandy CLAY with gravels, FILL, rubbish (brick) fragments, dark brown	0.0-0.2	N/A	N/A
NAT. HEY3-0.4-0.5	SAND, grey with small shell fragments m-cg	0.4-0.5	"	"
QC05 QC06 HEY3-0.9-1.0	SAND, grey, becoming coarser, quartz fragments, cg	0.9-1.0	"	"
HEY3-1.4-1.5	SAND, cg, dark grey with oxidised red-brown coloured	1.4-1.5	"	"
	cemented layer at 1.45mbgs

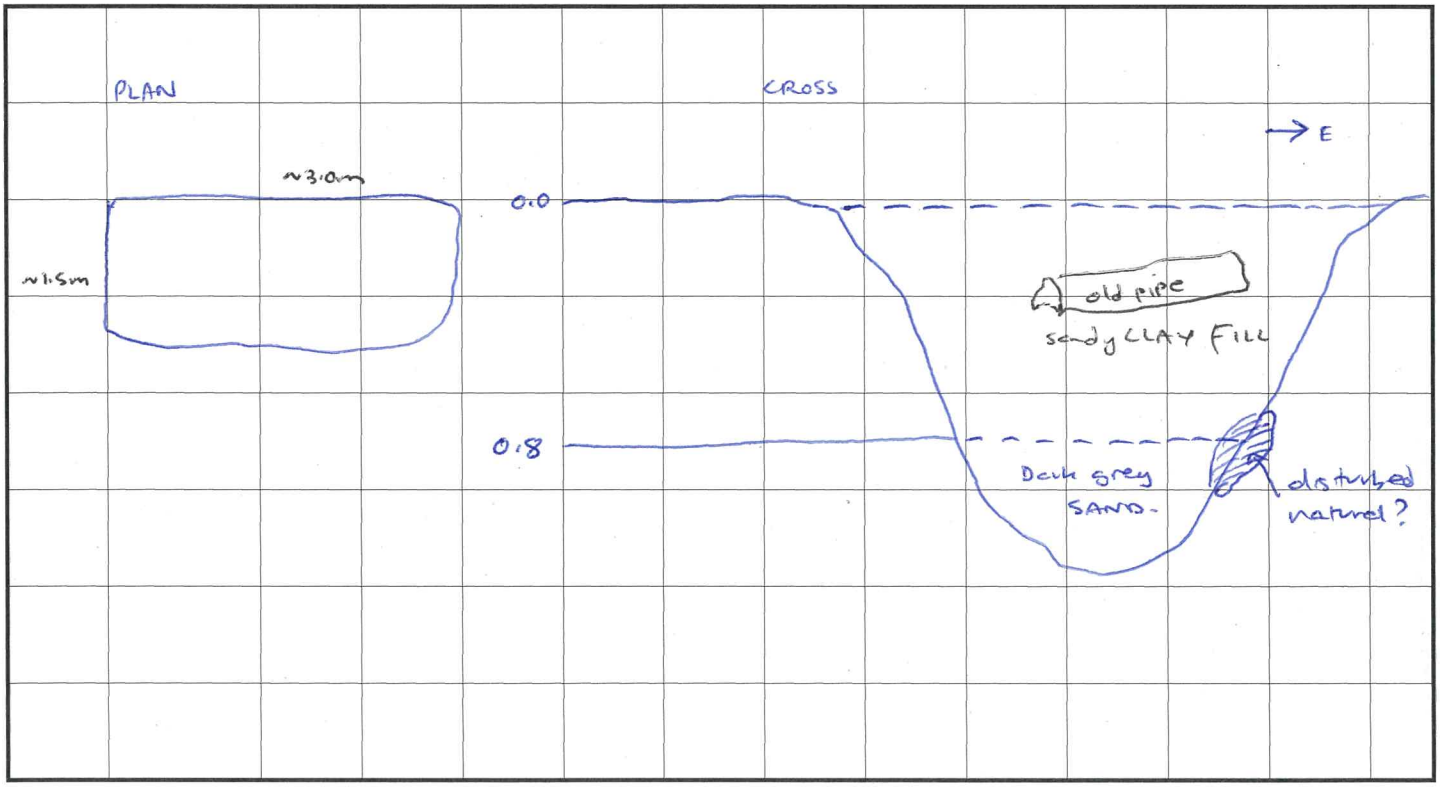
Sample ID	Soil Description (soil type, moisture, colour etc)	Depth (m)	Staining/ Odour (descriptive)	PID (ppm)
FILL	HEY4-0.0-0.2	Sandy CLAY, with boulders, bricks, wood, old Pipe fragments, brown	0.0-0.2	N/A	N/A
	HEY4-0.4-0.5	Sandy CLAY with boulders, rubbish	0.4-0.5	Red-brown	"
NAT.	HEY4-0.9-1.0	SAND, dark grey, m-cg, dk grey banding.	0.9-1.0	N/A	"
	HEY4-1.4-1.5	SAND, dark grey with very small shell fragments	1.4-1.5	N/A	"

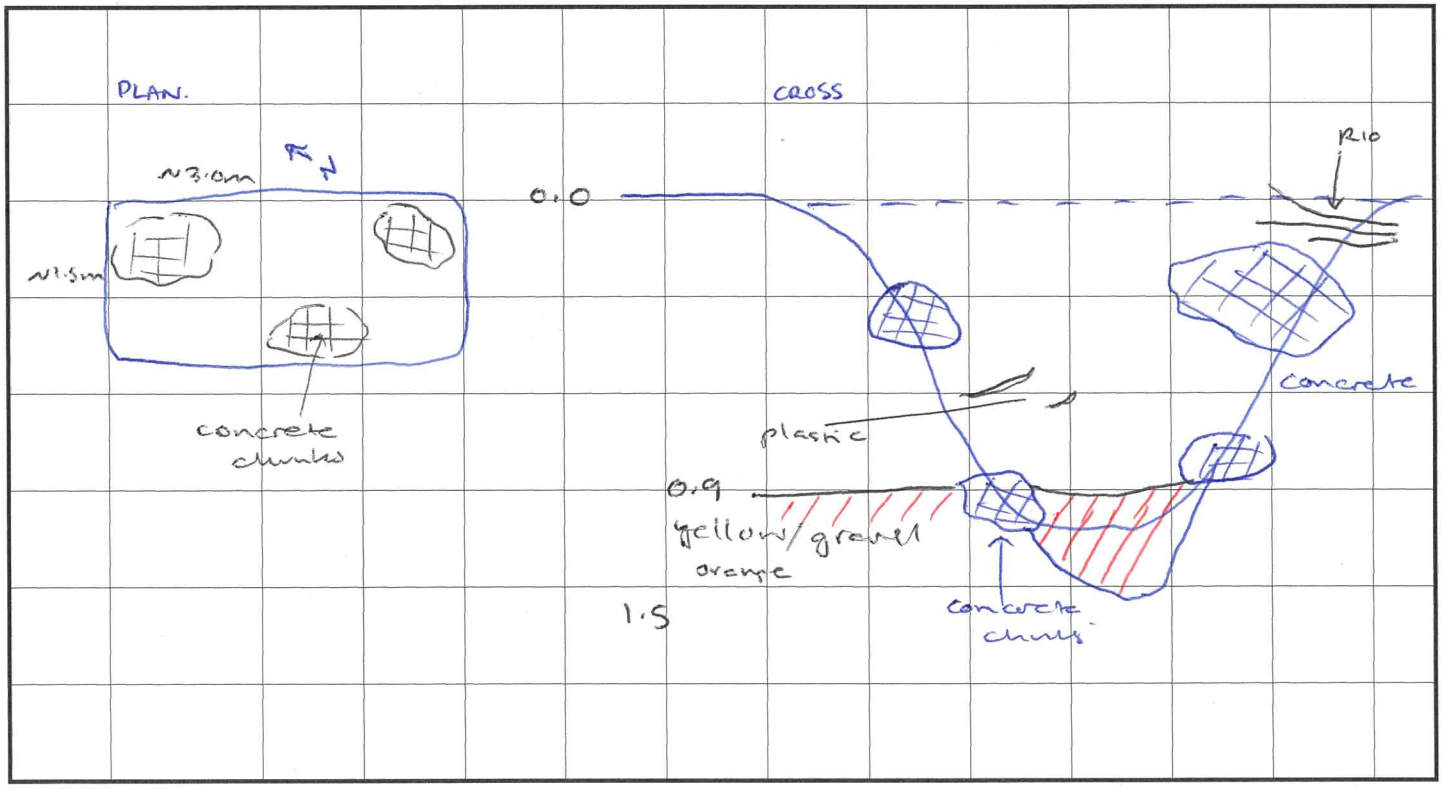
Sample ID	Soil Description (soil type, moisture, colour etc)	Depth (m)	Staining/ Odour (descriptive)	PID (ppm)
HEY5-0.0-0.2	Sandy CLAY, with concrete block, RIO wire, plastic fragments	0.0-0.2		
HEY5-0.4-0.5	Sandy CLAY, yellow with gravels concrete chunk, brick	0.4-0.5		
HEY5-0.9-1.0	Sandy CLAY, yellow with gravels possible FILL	0.9-1.0		
HEY5-1.4-1.5	Sandy CLAY, yellow with gravels	1.4-1.5

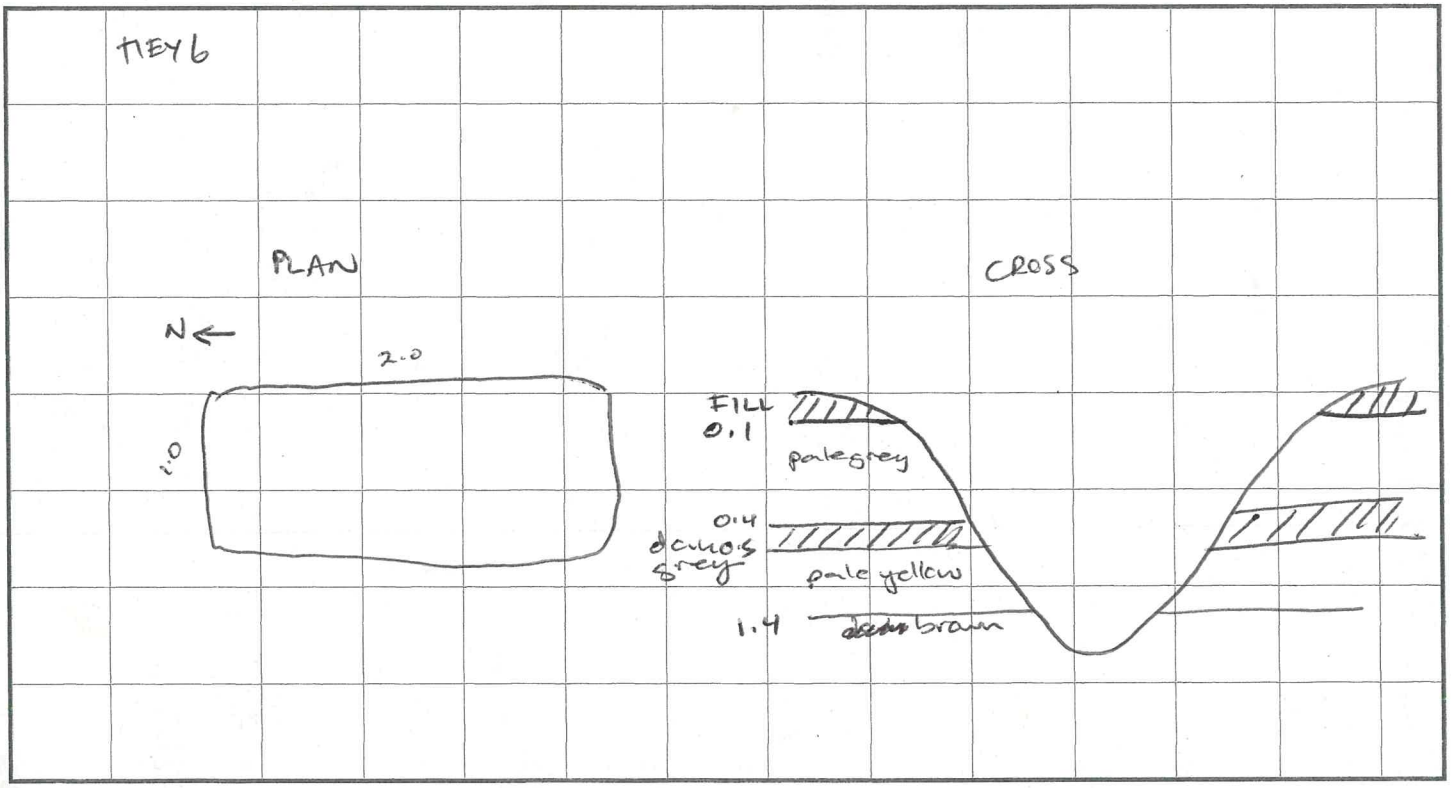
Sample ID	Soil Description (soil type, moisture, colour etc)	Depth (m)	Staining/ Odour (descriptive)	PID (ppm)
QC03 2004 HEY6_0.1-0.3	Sandy CLAY, dark brown, organic rich for top 0.1. then pale grey, mp.	0.1-0.3		
HEY6_0.4-0.5	sandy CLAY, dark grey with gravels of mudstone.	0.4-0.5		
HEY6_0.9-1.0	sandy CLAY, pale yellow with rounded quartz gravels and mudstone clasts/boulders	0.9-1.0		
HEY6_1.4-1.5	Sandy CLAY, brown with gravels incl. mudstone, dark grey rock (limestone?) and rounded quartz. dry	1.4-1.5

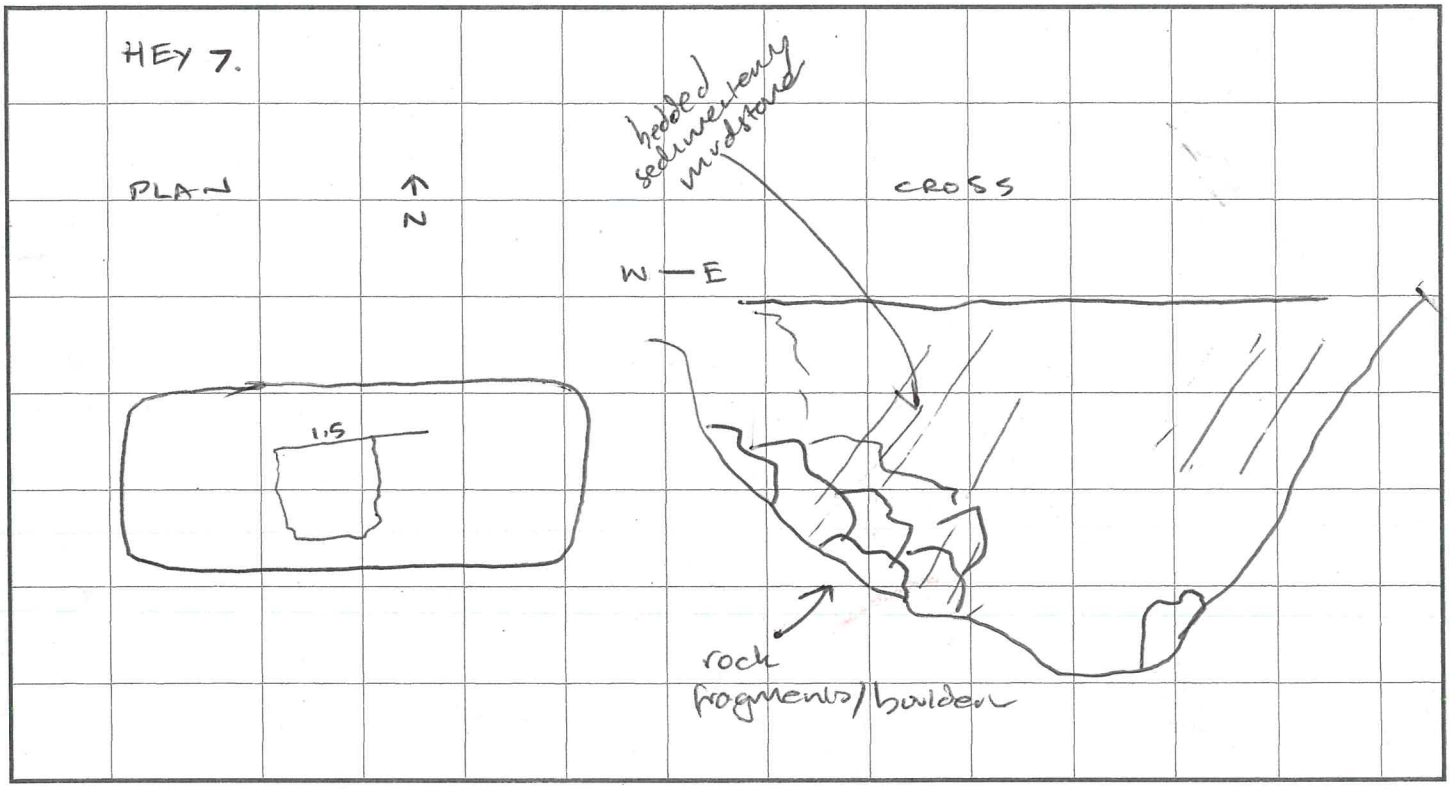
Sample ID	Soil Description (soil type, moisture, colour etc)	Depth (m)	Staining/ Odour (descriptive)	PID (ppm)
HEY7_0.0-0.2	gclayey SAND with GRAVELS and boulders. yellow-grey, (boulders up to 30cm). Mg.	0.0-0.2	None	None.
HEY7_0.5-0.6	" QC01 + QC02.	0.5-0.6	none	none
~~HEY7_0.6-1.0~~	~~gclayey SAND with GRAVELS and boulders~~	~~0.6-1.0~~	~~none~~	~~none~~
HEY7_0.9-1.0	CLAY Mp, pale grey with boulders and wood fragments and gravels, dry.	0.9-1.0	none	none.
HEY7_1.4-1.5	"	1.4-1.5	none	none

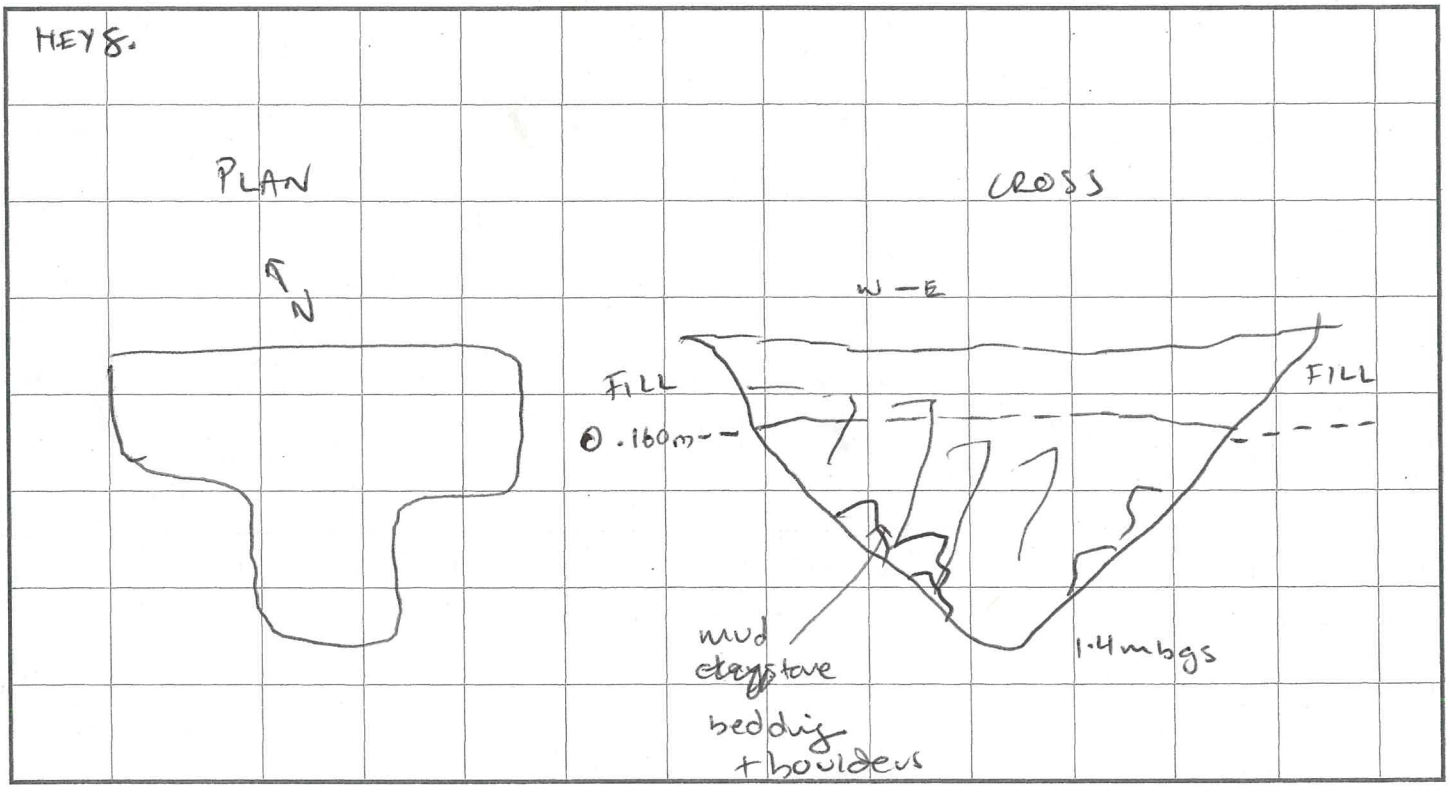
Sample ID	Soil Description (soil type, moisture, colour etc)	Depth (m)	Staining/ Odour (descriptive)	PID (ppm)
FILL HEY8_0.0-0.3	clayey SAND, fg, with boulders and gravels, mainly mudstone fragments; grey.	0.0-0.3.		
NAT. HEY8_0.4-0.5	clayey SAND, mg, with boulders + gravels. yellow.	0.4-0.5		
HEY8_0.6-0.7	clayey SAND, mg, with boulders and some rounded pebbles	0.6-0.7		
HEY8_0.9-1.0	clayey SAND, fg with boulders + rounded quartz pebbles, orange mottling	0.9-1.0		
HEY8_1.3-1.4	Sandy CLAY yellow with orange mottling. with boulders dry	1.3-1.4

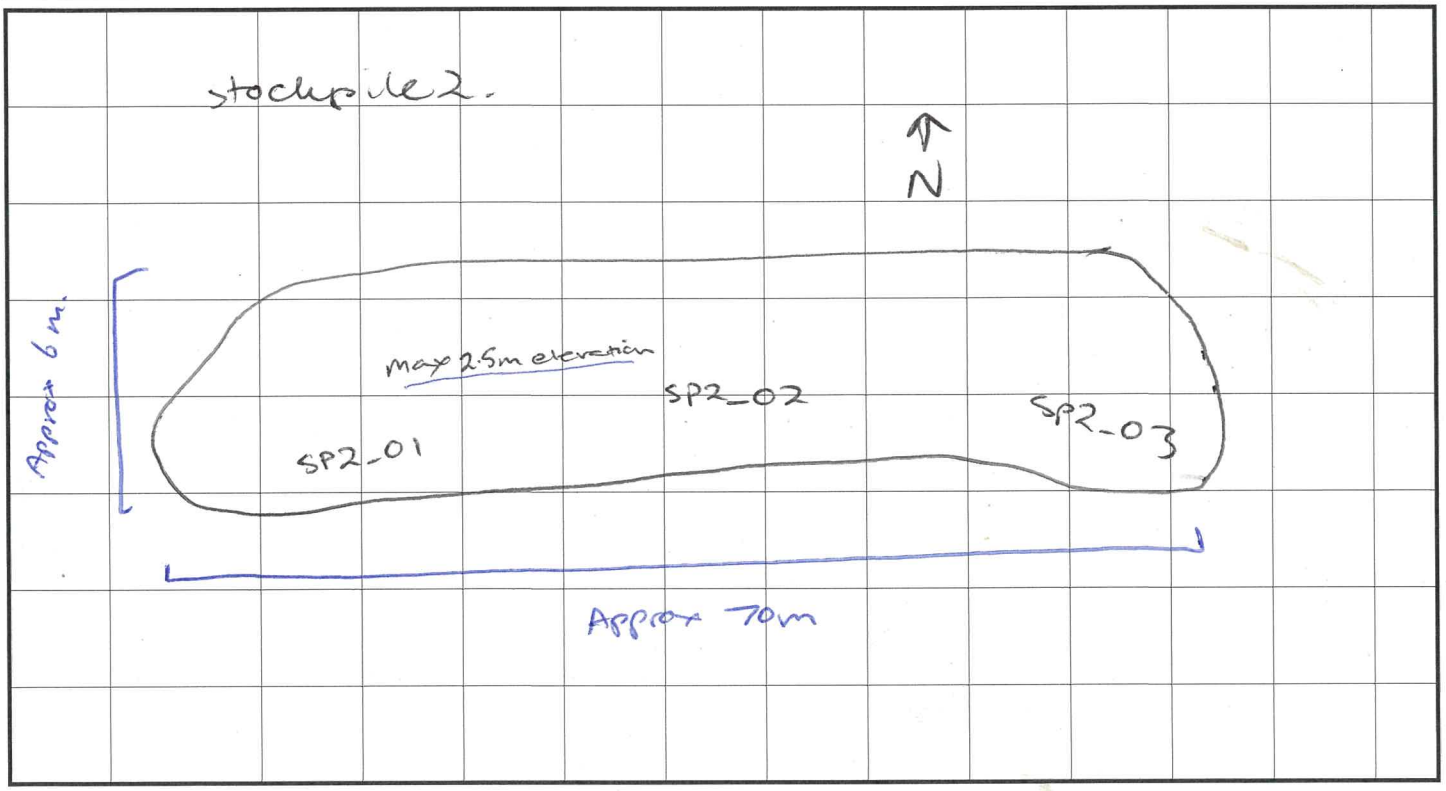
Sample ID	Soil Description (soil type, moisture, colour etc)	Depth (m)	Staining/ Odour (descriptive)	PID (ppm)
SP2_01	sandy CLAY with gravels + rubbish - plastic, clay pipe	0.2-0.3	organic odour	
SP2_02	sandy CLAY with gravels and concrete chunks	0.2-0.3	organic odour	
SP2_03	sandy CLAY with gravels and rubbish - glass fragments	0.2-0.3	organic odour

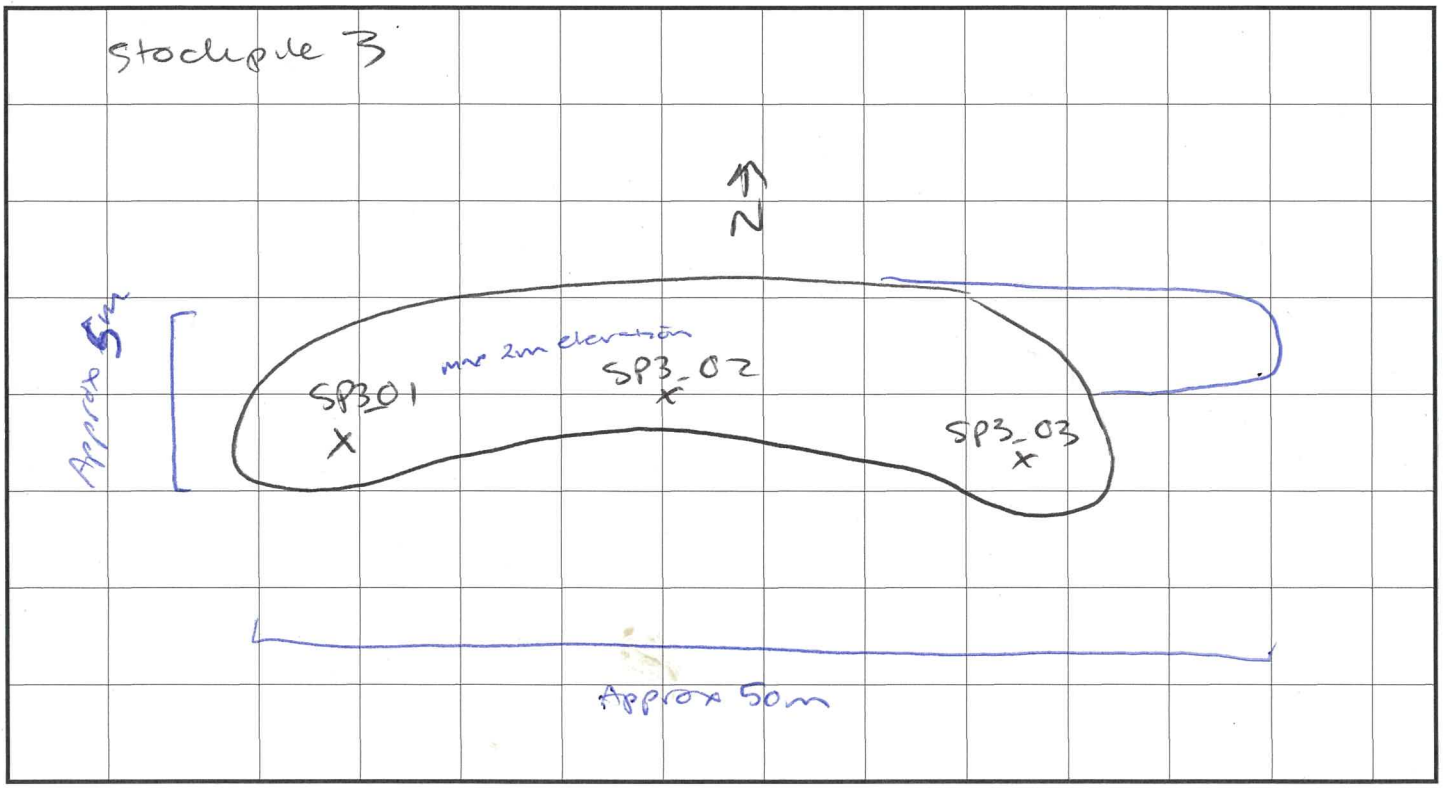
Sample ID	Soil Description (soil type, moisture, colour etc)	Depth (m)	Staining/ Odour (descriptive)	PID (ppm)
SP3_01	~~clay~~ sandy CLAY, dark brown, organic rich with brick fragments			
SP3_02	into asbestos zone – stopped			
SP3_03

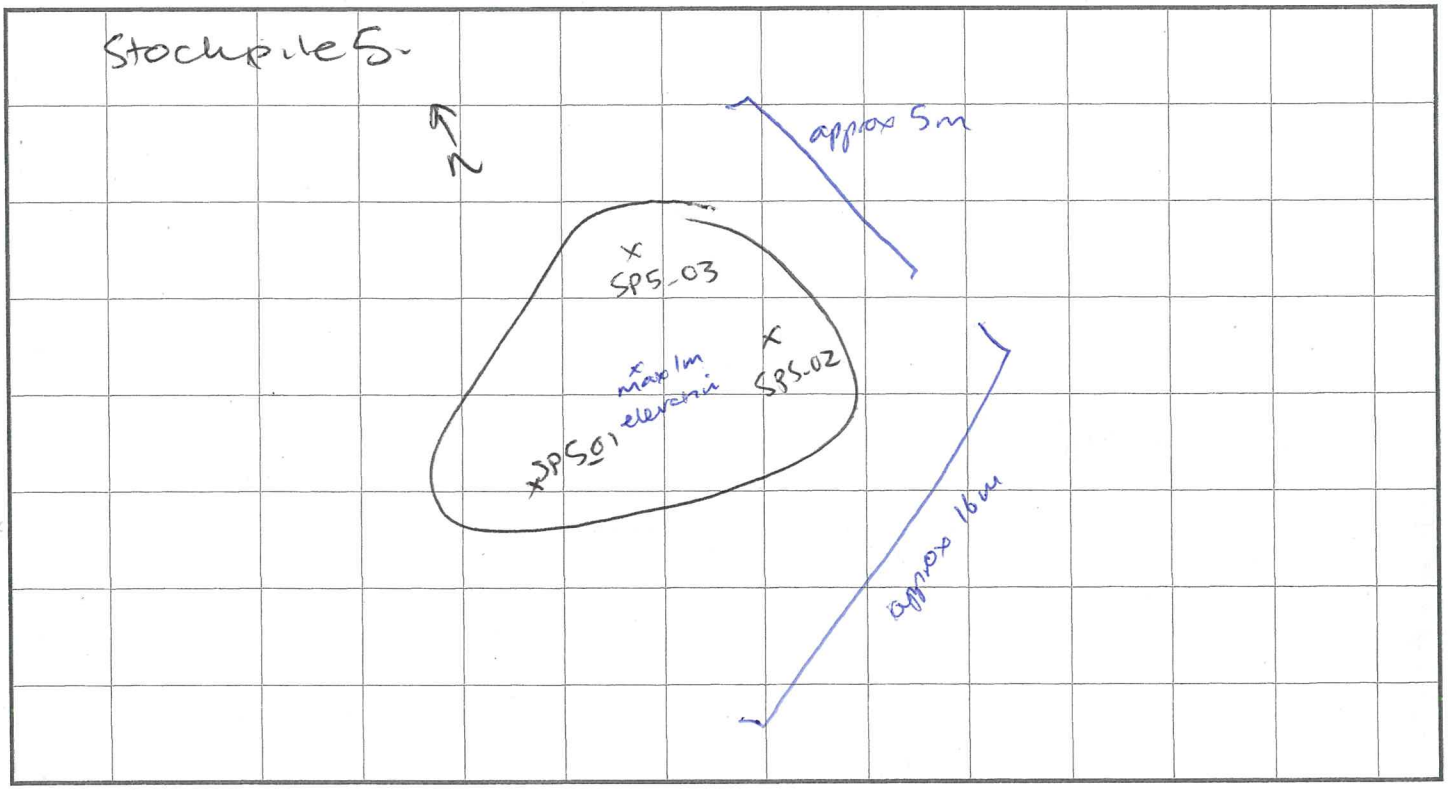
Sample ID	Soil Description (soil type, moisture, colour etc)	Depth (m)	Staining/ Odour (descriptive)	PID (ppm)
SP5_01	Sandy CLAY with gravels and wood fragments	0.1-0.2		
SP5_02	"	0.0-0.1		
SP5_03	"	0.0-0.1

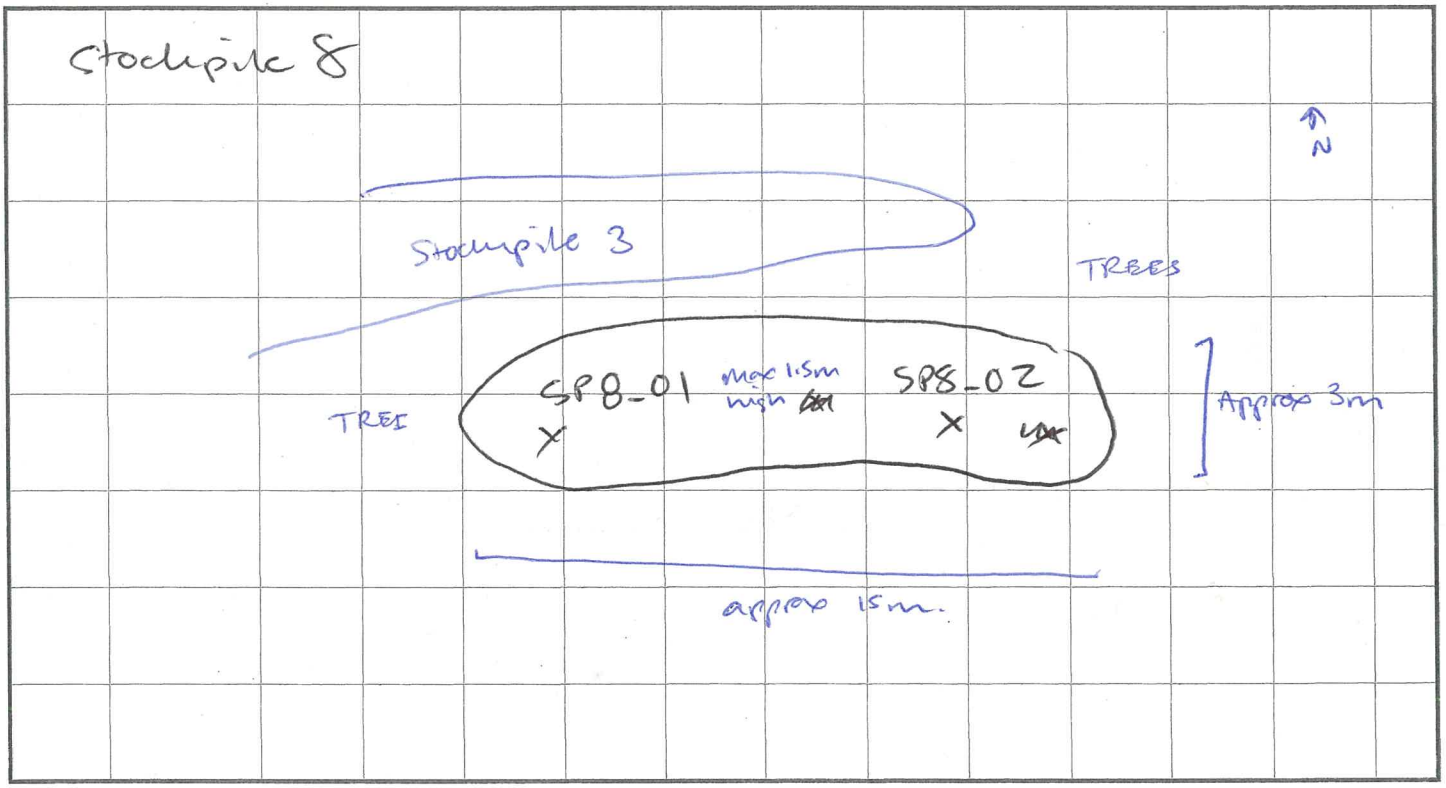
Sample ID	Soil Description (soil type, moisture, colour etc)	Depth (m)	Staining/ Odour (descriptive)	PID (ppm)
SP8_01	Sandy CLAY with gravels - no rubbish visible	0.2-0.3		
SP8_02	sandy CLAY with gravels	0.2-0.3

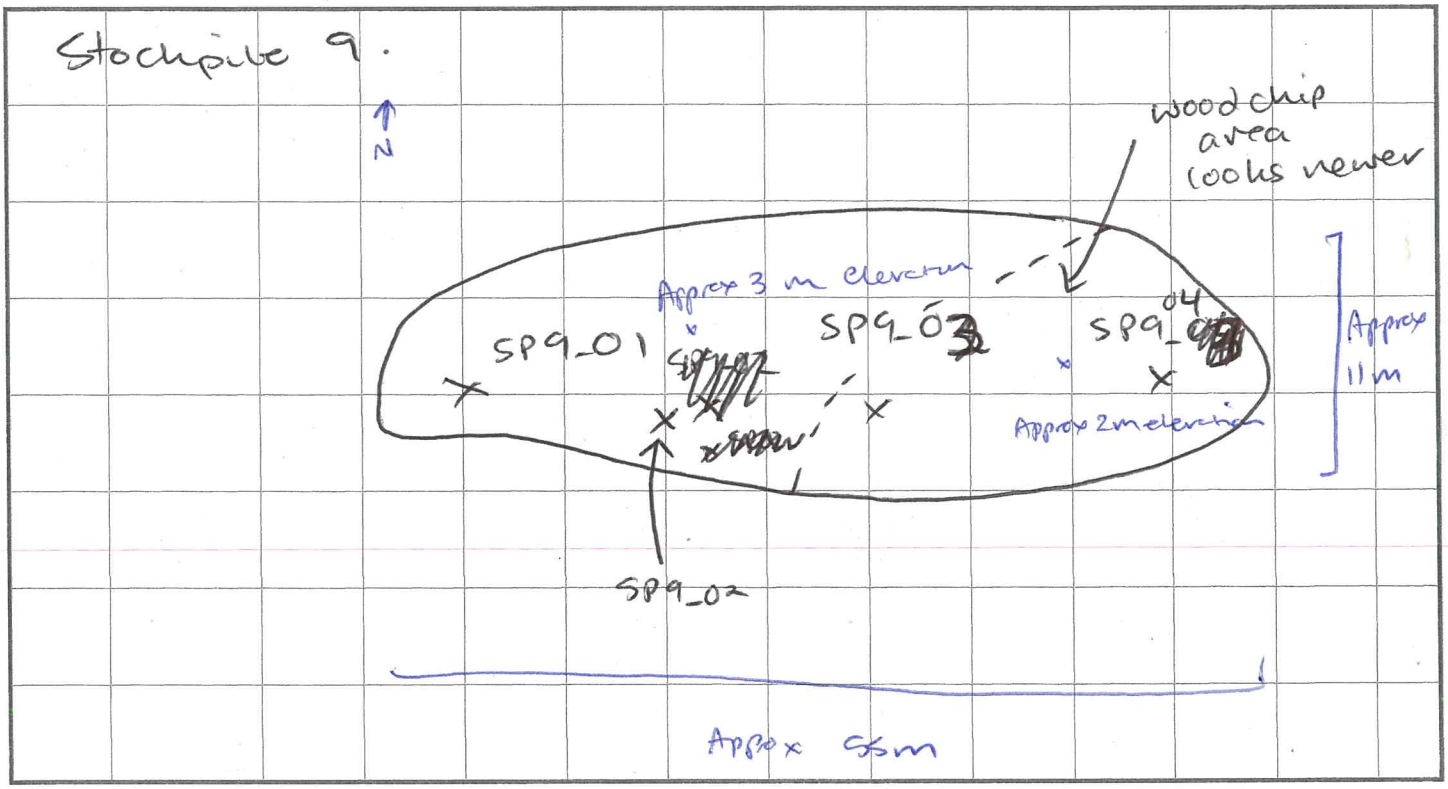
Sample ID	Soil Description (soil type, moisture, colour etc)	Depth (m)	Staining/ Odour (descriptive)	PID (ppm)
QC07 2008 SP9_01	Sandy CLAY with gravels	0.2-0.3	Organic odour white staining	
SP9_02	Sandy CLAY with gravels and boulders	0.2-0.3		
SP9_03	Sandy CLAY with gravels. Dark brown and lots of bark chips.	0.2-0.3		
SP9_04	Sandy CLAY with gravels, dark brown and lots of bark chips	0.3 - 0.4

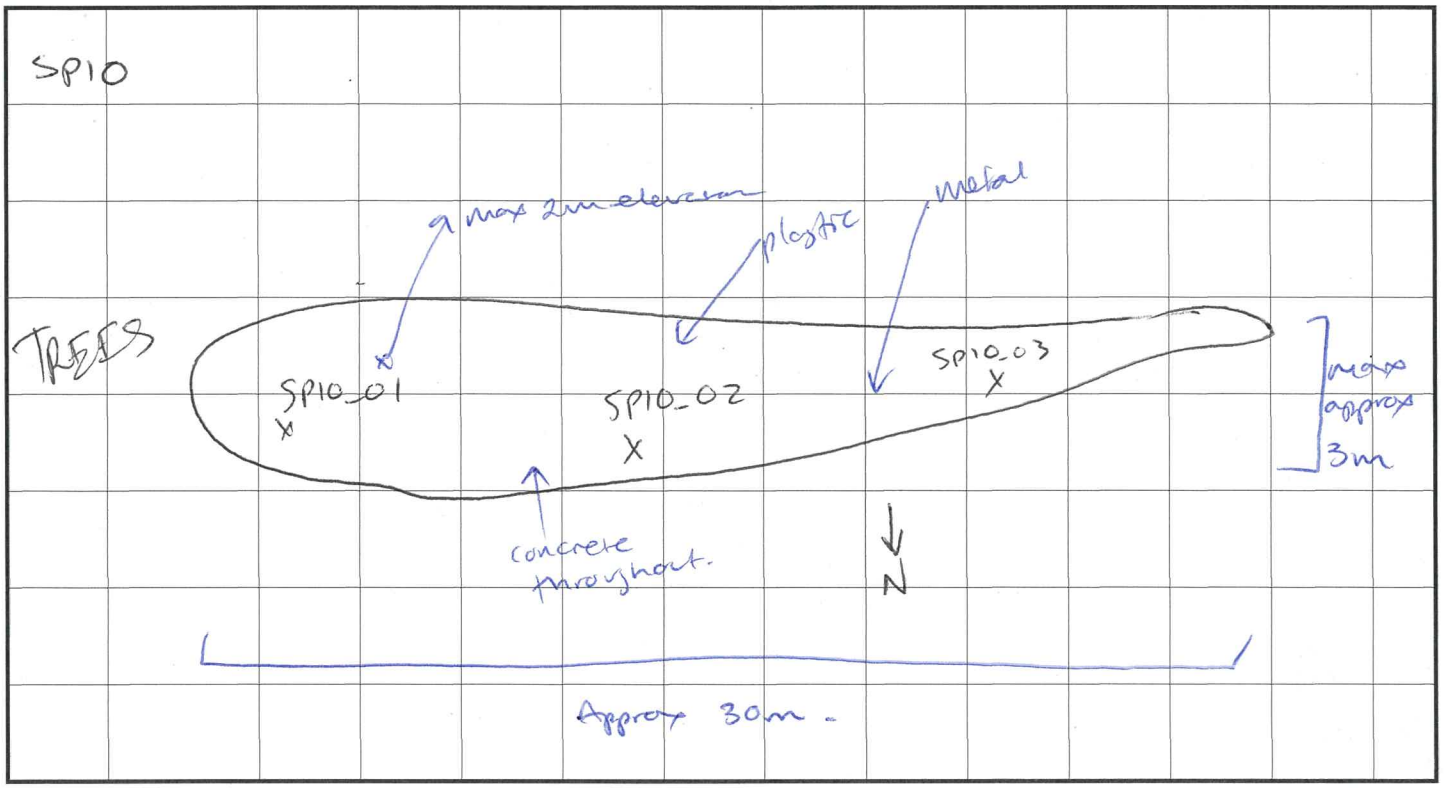
Sample ID	Soil Description (soil type, moisture, colour etc)	Depth (m)	Staining/ Odour (descriptive)	PID (ppm)
SP10_01	Sandy clay with wood, brick and concrete	0.1-0.2		
SP10_02	"	0.1-0.2		
SP10_03	"	0.1-0.2
