**Application No:** DA 2022/76  
**Council reference:** SP: CF 2920337 & 9296310  
**Land:** Corner of Minna Road and Bass Highway (18 and 20 Minna Road),  
Heybridge and 22 Minna Road, Heybridge, Tasmania  
**Proposal:** Heybridge Converter Station, Marinus Link

## Response to Requests for Additional Information dated 28 November 2024

**LANDSLIDE RISK ASSESSMENT  
PROPOSED CONVERTER STATION  
BASS HIGHWAY, HEYBRIDGE**

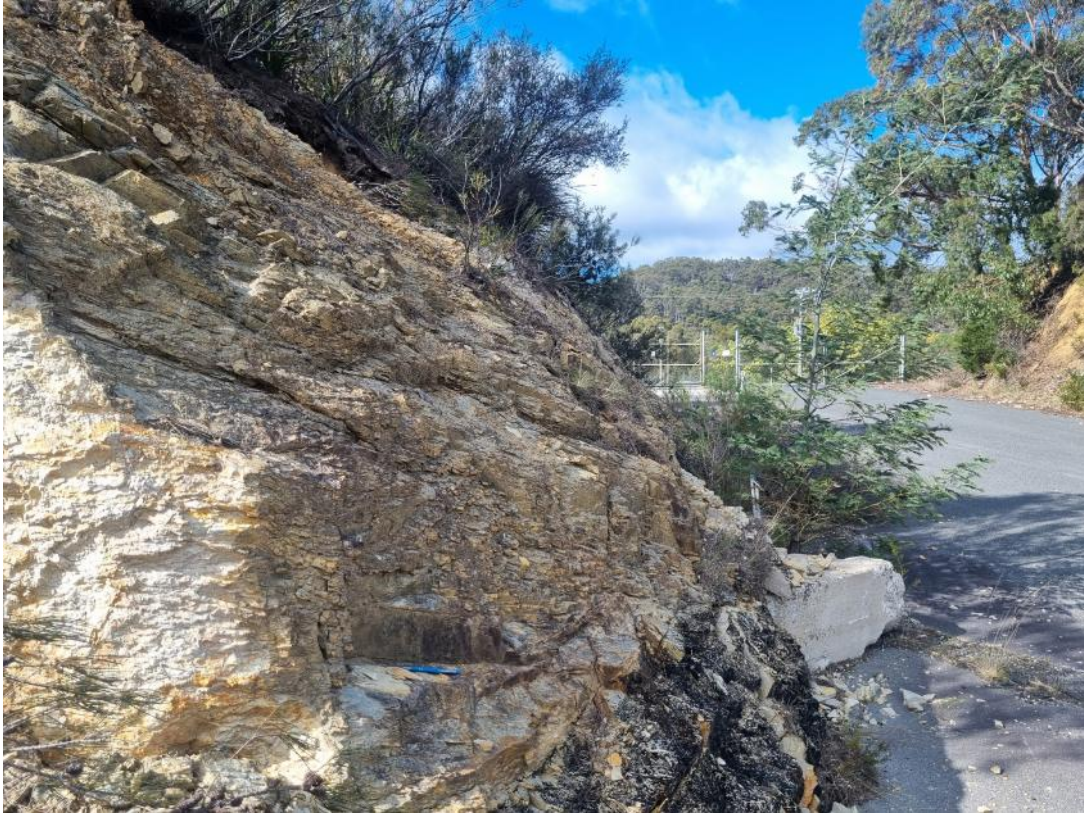
Photo 1: Oonah Formation turbidites exposed in cut face at entrance to Heybridge site, looking ~south.

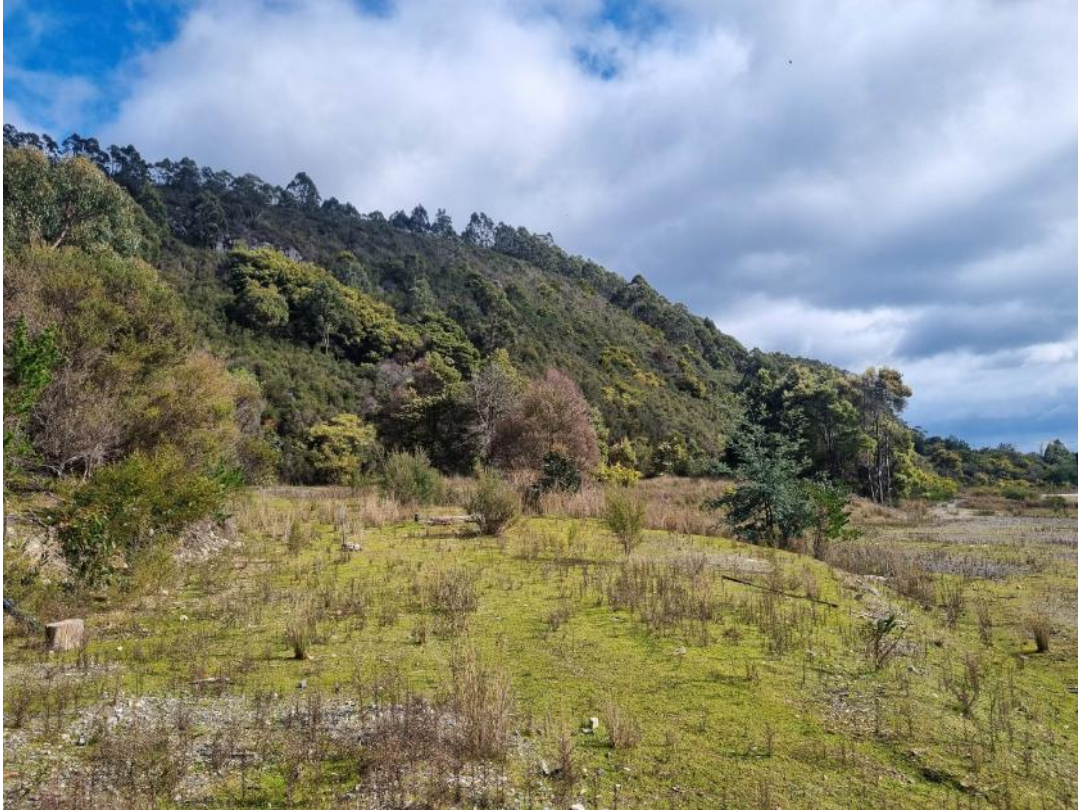
Photo 3: Steep escarpment to the south of Heybridge site, looking northwest. The low bench where the new cut earthworks are proposed is in the foreground.

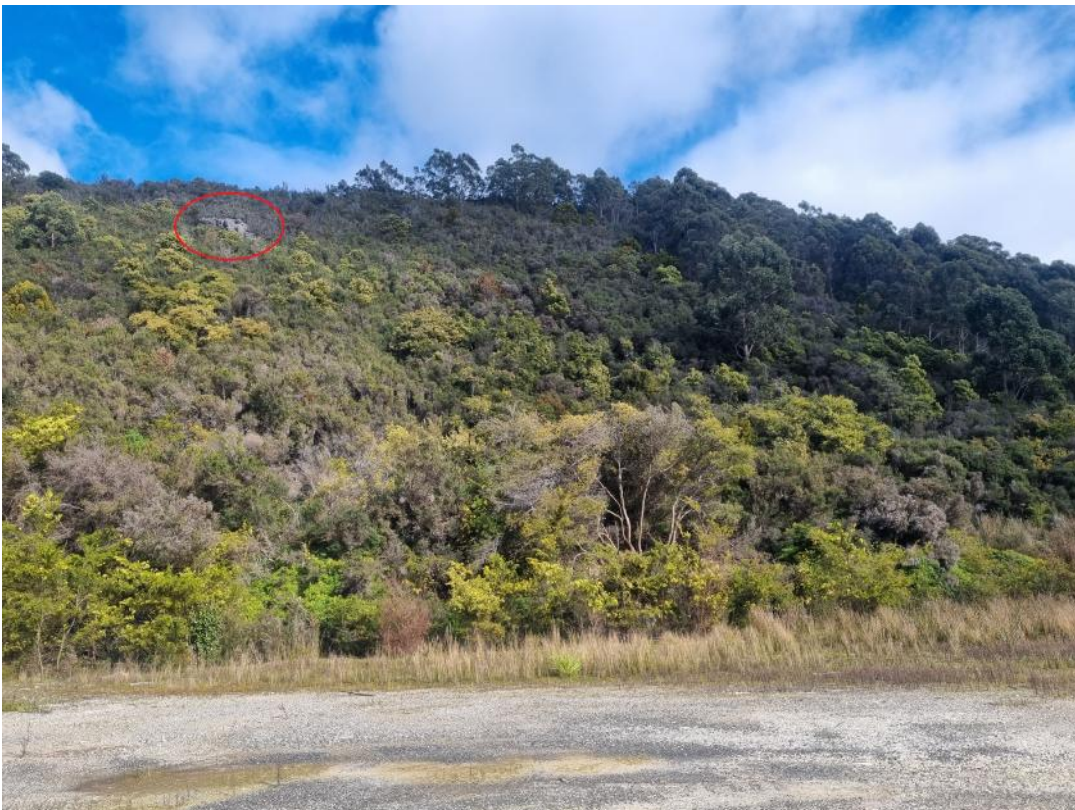
Photo 4: Steep escarpment to the south of Heybridge site with visible outcropping turbidites (red circle), looking west.

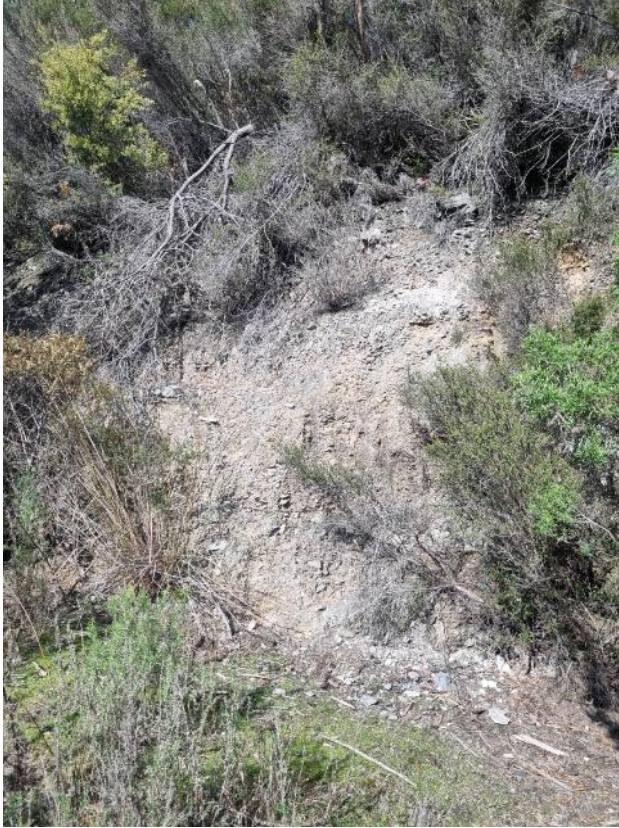
Photo 5: Natural colluvium at toe of escarpment, looking southwest.

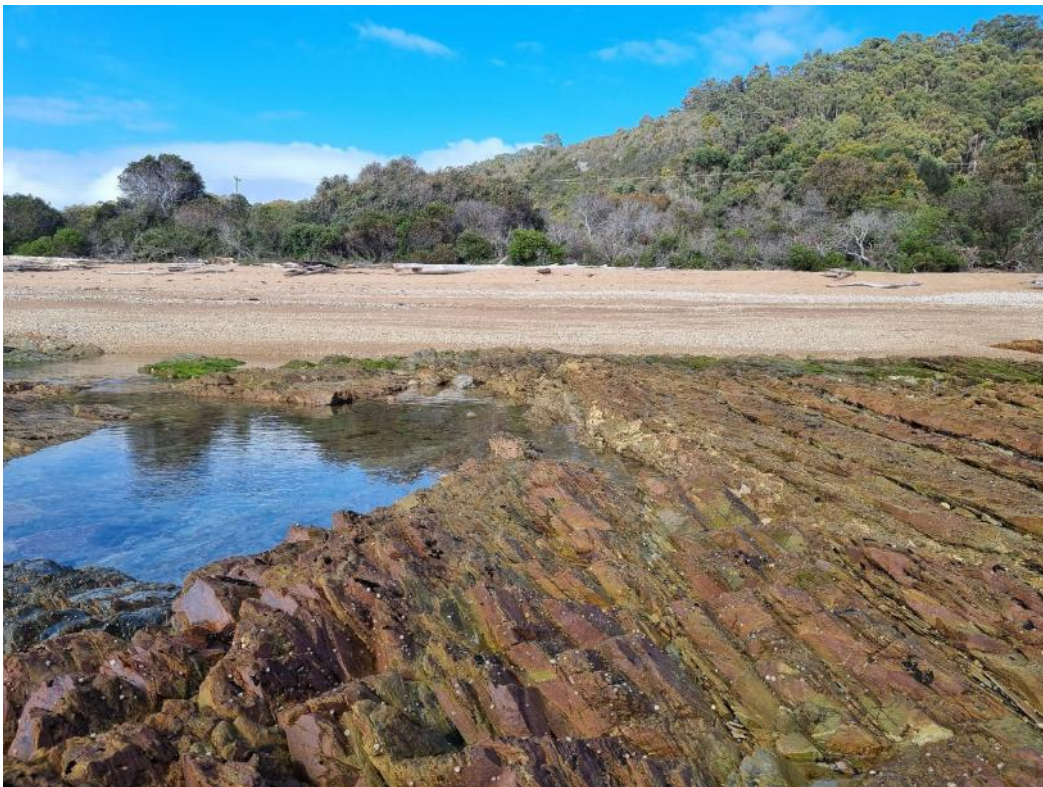
Photo 6: Moderately dipping turbidite sequence (Oonah Formation) exposed on shoreline (BH4 location in background), looking southwest.

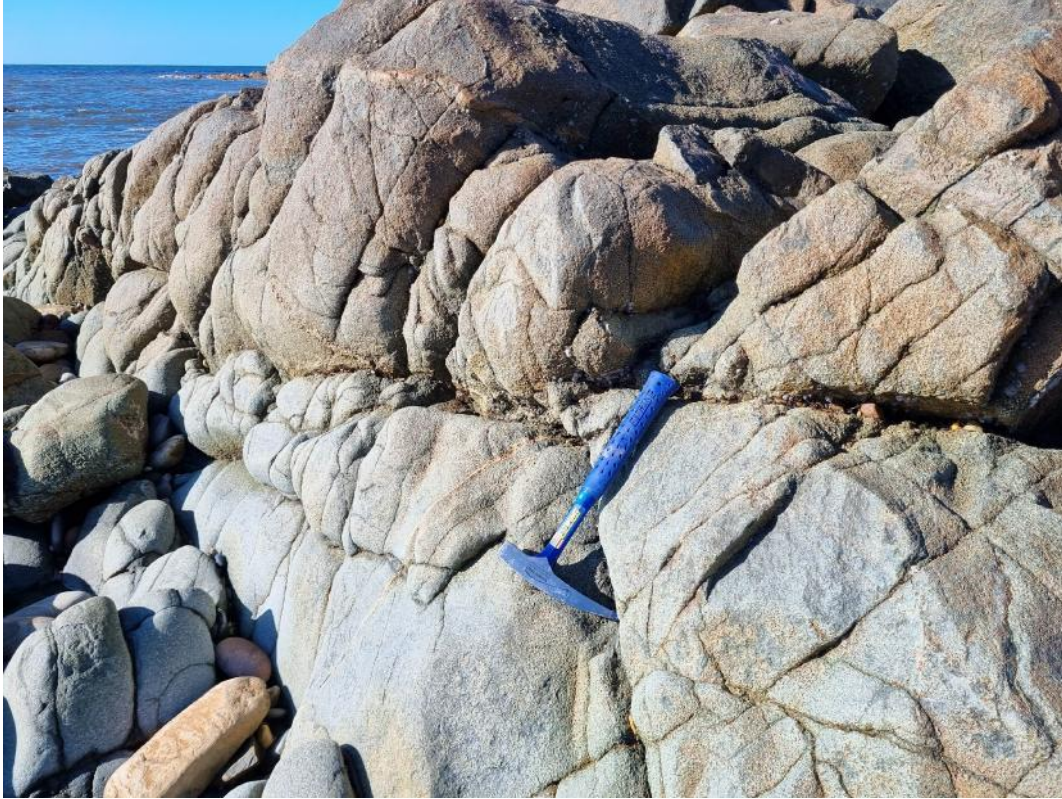
Photo 7: Dolerite (Cooee Dolerite) exposed on shoreline, looking northeast.
